NIST Technical Note 1910

A Case Study of a Community Affected by the Waldo Fire – Event Timeline and Defensive Actions

November 2015

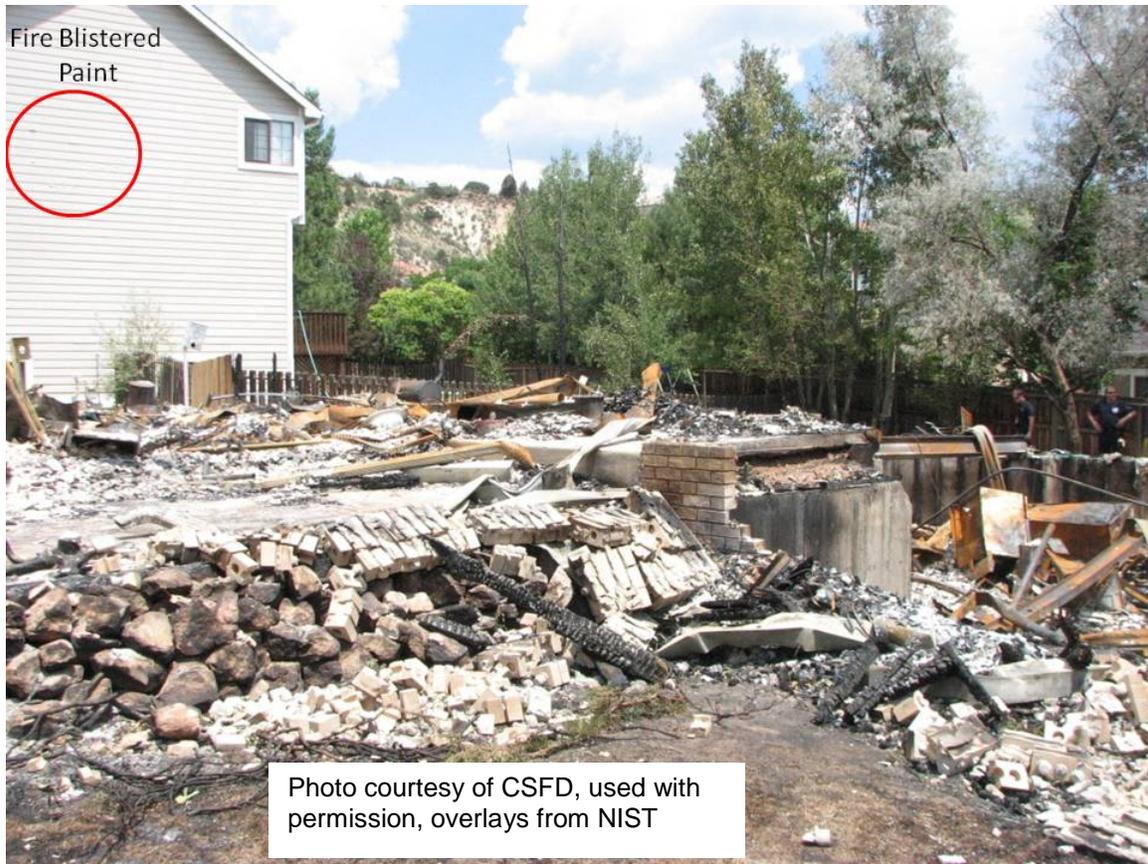
Many post-fire assessments focus on documenting major damage and destruction to primary structures. The blistering of paint barely visible in Figure 4 demonstrates the missing of minor-scale damage prevalent in damage assessments of major WUI incidents. In many cases, this type of minor-scale damage was used to help geolocate first responder observations.

Figure 4 Ground image taken by local damage inspectors of a destroyed primary structure barely showing fire blistered paint on an adjacent primary structure in the background.

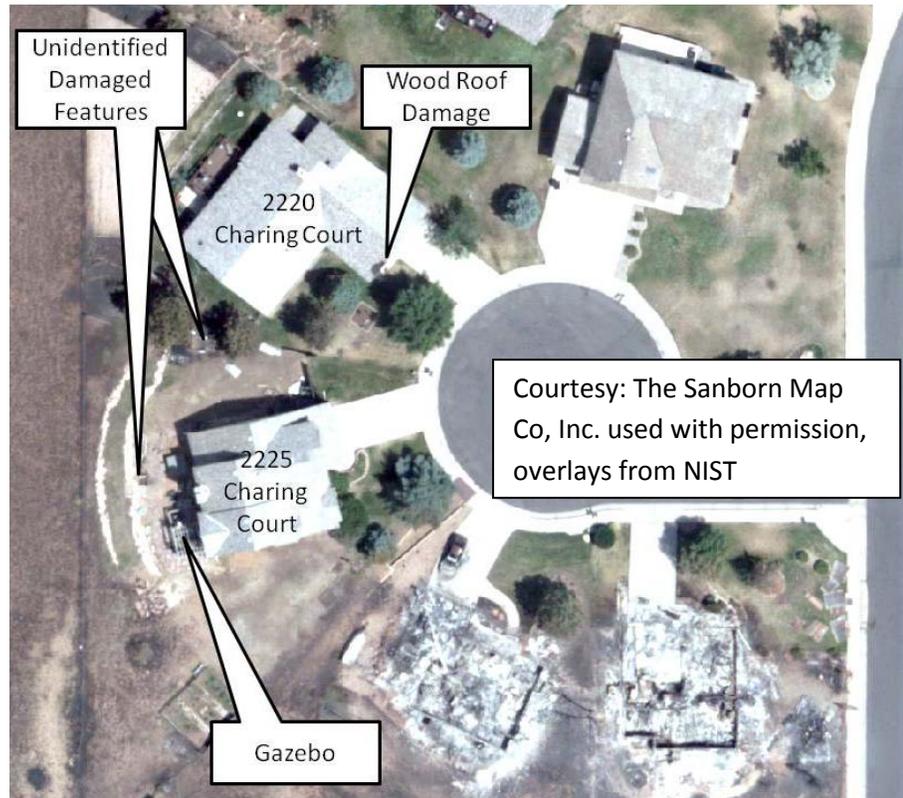
Also shown in Figure 6 are a gazebo at 2225 Charing Court and the lack of a gazebo at 2220 Charing Court along with various unidentified burned and damaged features. Furthermore, discussions with homeowners at 2220 Charing Court confirming roof damage and damage to railroad ties along with identifying a heat damaged sliding glass door that required replacement. Finally, analysis of 2225 Charing Court in Bing Maps Streetside showed that 2225 Charing Court still had a wood roof as of 2014.

Figure 6 Damage on Charing Court used to geolocate first responder defensive action locations.

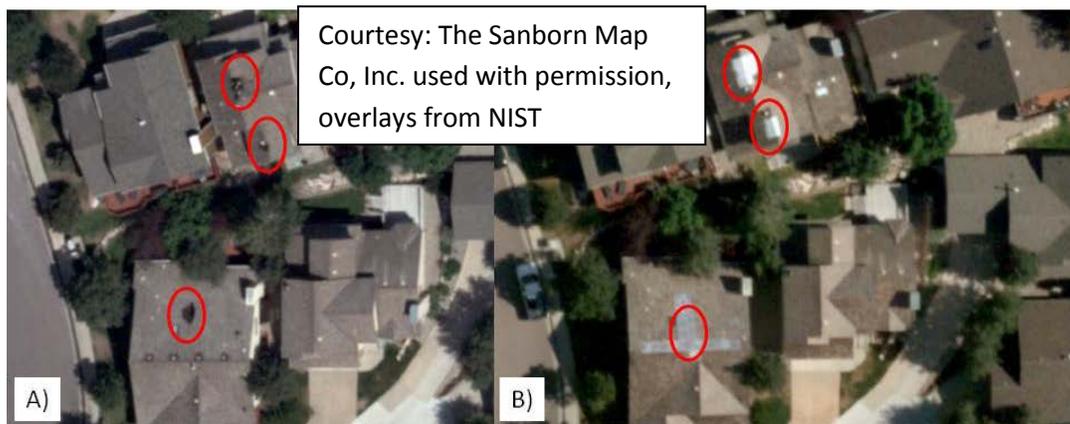
Figure 7 Post-fire aerial images of damaged wood roofs. A). Aerial image recorded on 6/28/2012 showing black marks on wood shake roofs. B). Aerial image recorded on 7/12/2012 showing initial repairs to roofs.

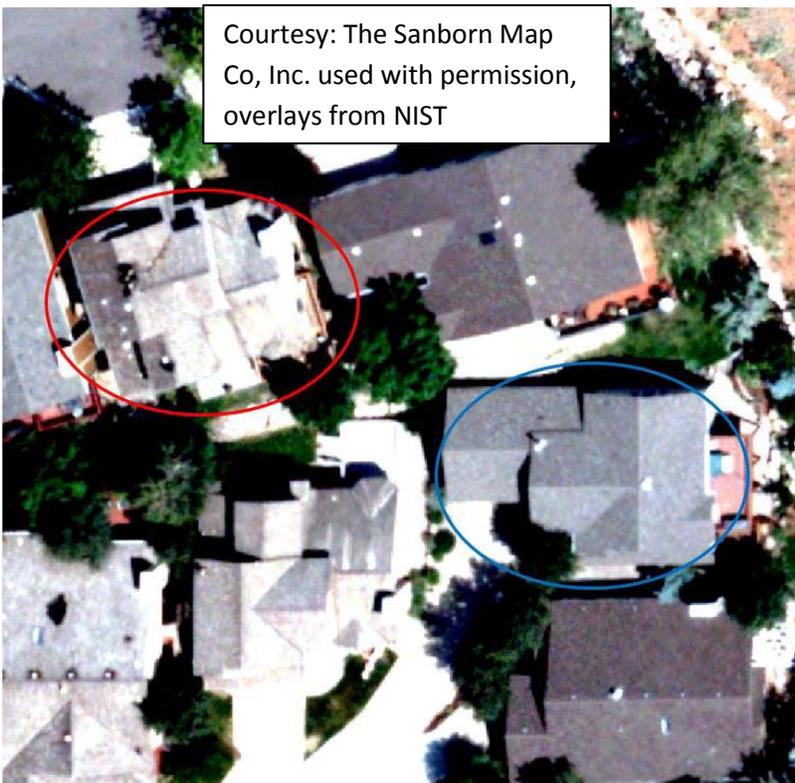
Figure 8 Two potentially fire damaged roofs. The primary structure circled in blue had anecdotal accounts of damage from the homeowner while the structure in red has clear visible evidence of damage.

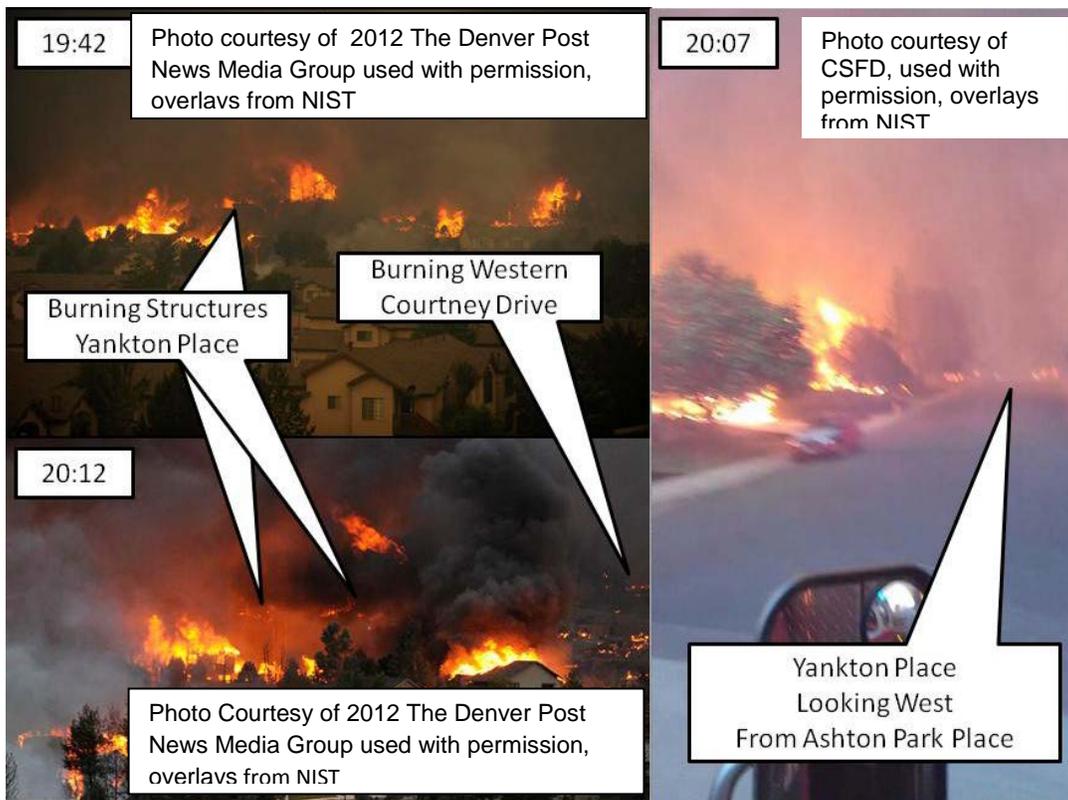
Figure 11 Evidence of early ignitions on Yankton Place and Western Courtney Drive through possible identification of primary structures as foundations.

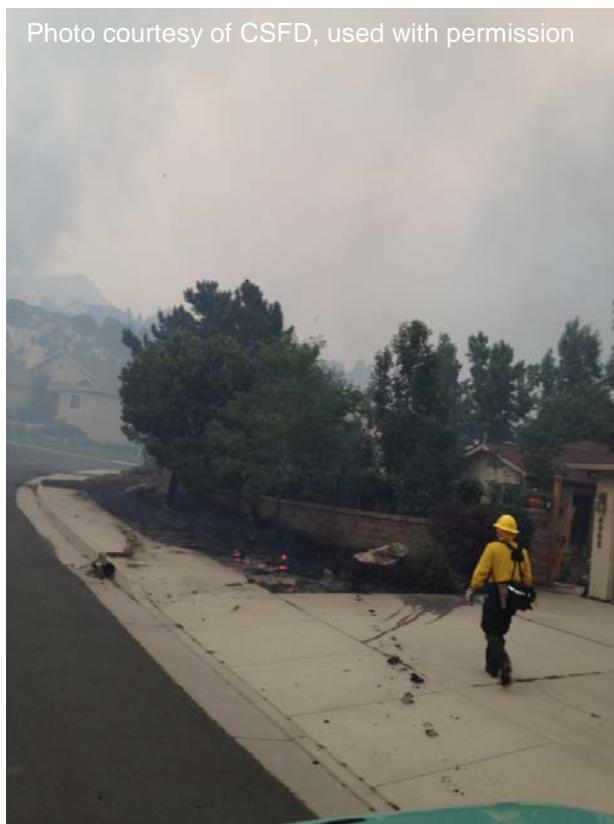
Figure 12 Image showing first responder hand work associated with containment of a burning primary structure.

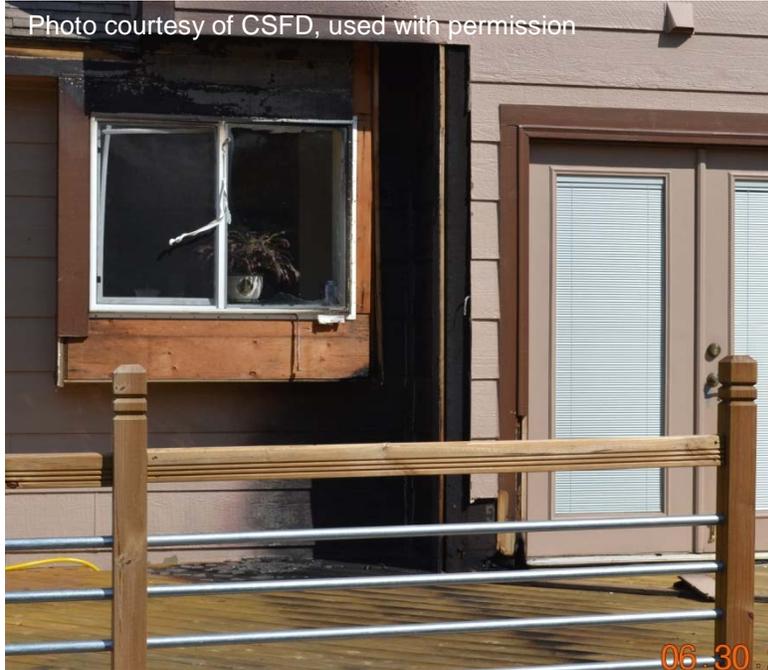
Figure 15 Ignition in a re-entrant corner area with precise ignition location not determined in this case.

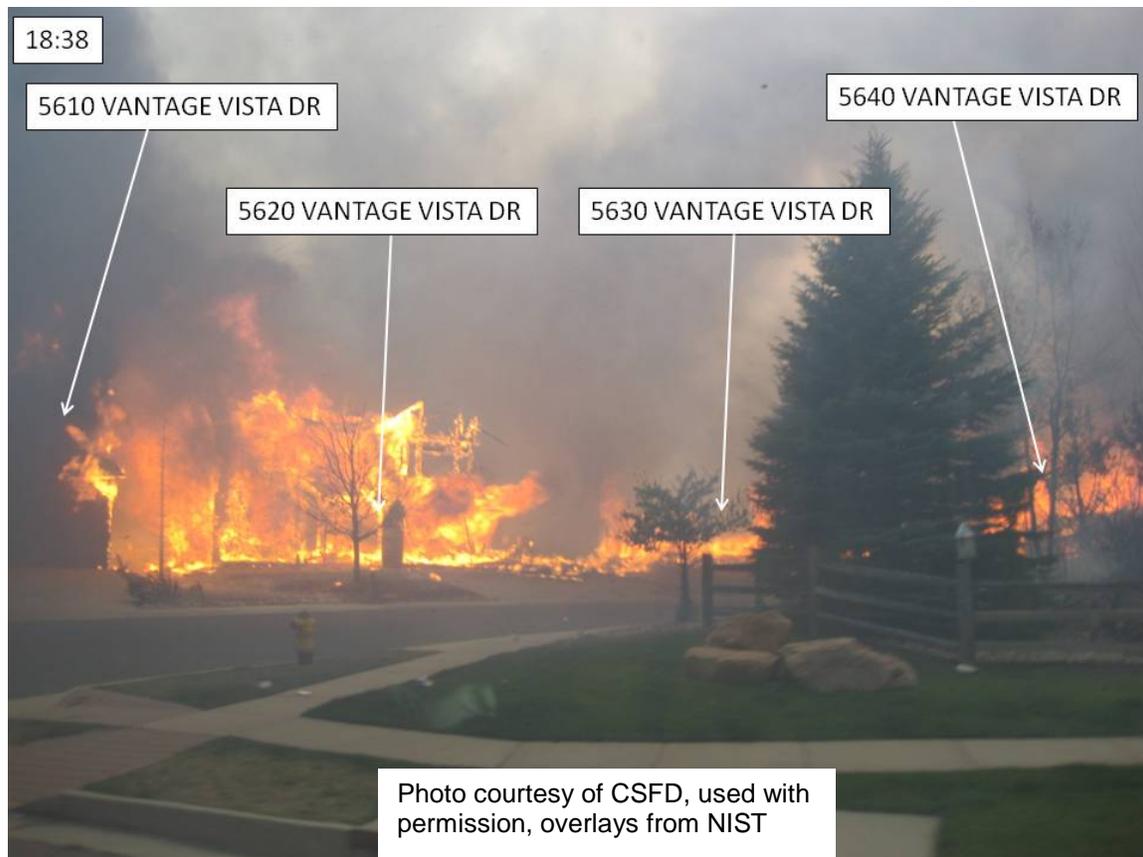
Figure 38 Image showing structure to structure fire spread on primary structures ignited by 18:38.

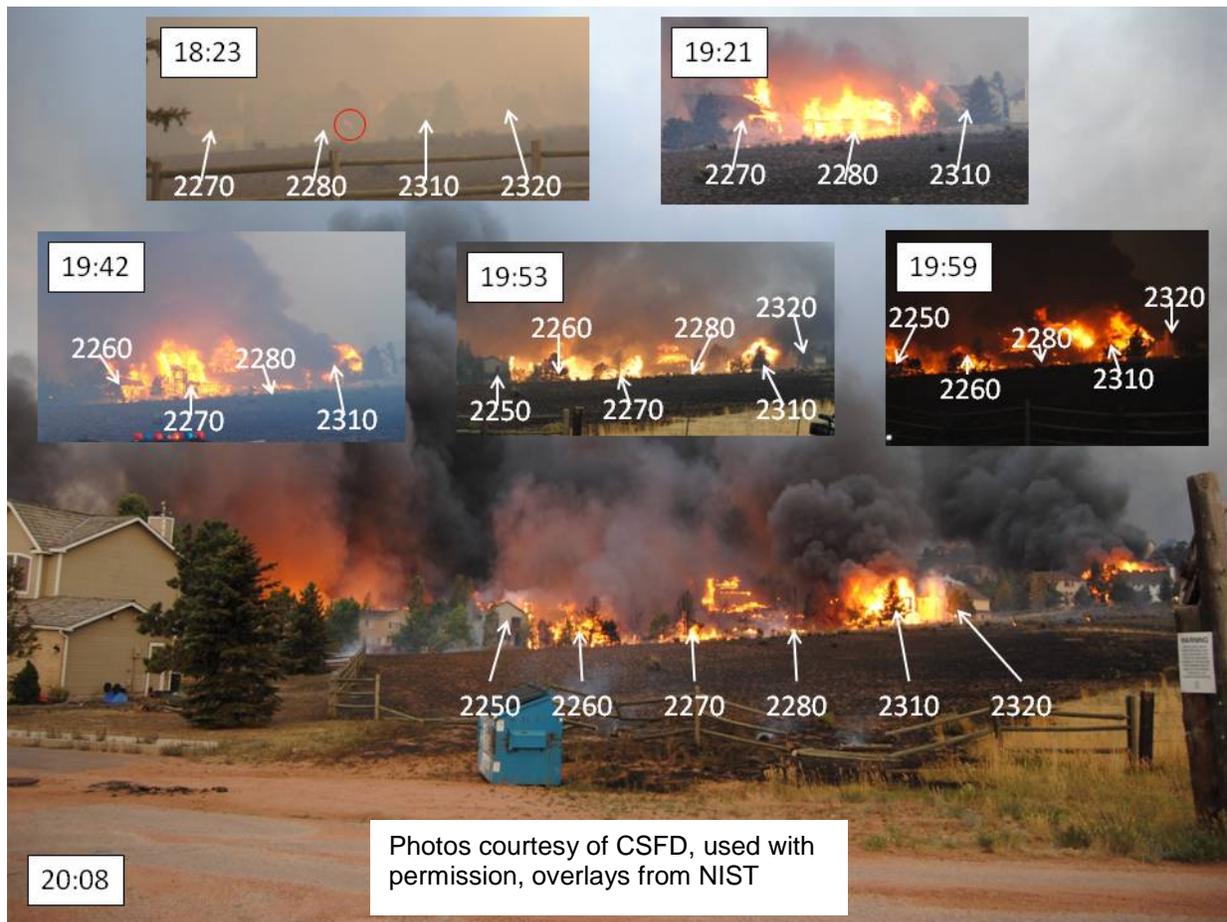
Figure 39 Time lapse images of burning on the northern side of Courtney Drive. White text boxes with black outlines portray burning times. White text portrays addresses of continuously adjacent primary structures from 2250 and 2320. All images are oriented to the south.

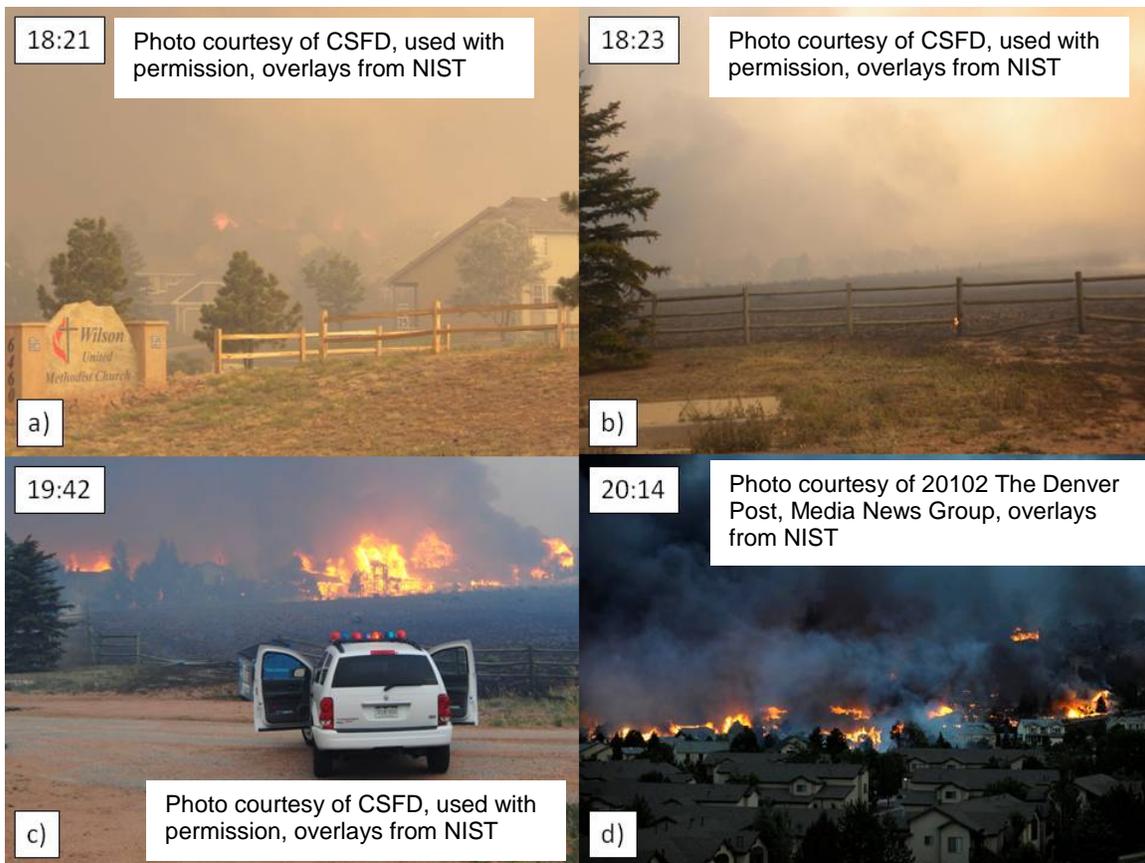
Figure 40 Evidence of limited number of early ignitions on Courtney Drive. a) Image looking to the west showing high flame heights on the east side of Courtney Drive, near the bend in the street. b) Image looking to the south showing flames either on 2280 Courtney Drive or behind it. c) Image looking to the south showing primary structures involved on the south side of Courtney Drive. d) Image looking to west showing foundations on the west and east side of Courtney Drive and Yankton Place.

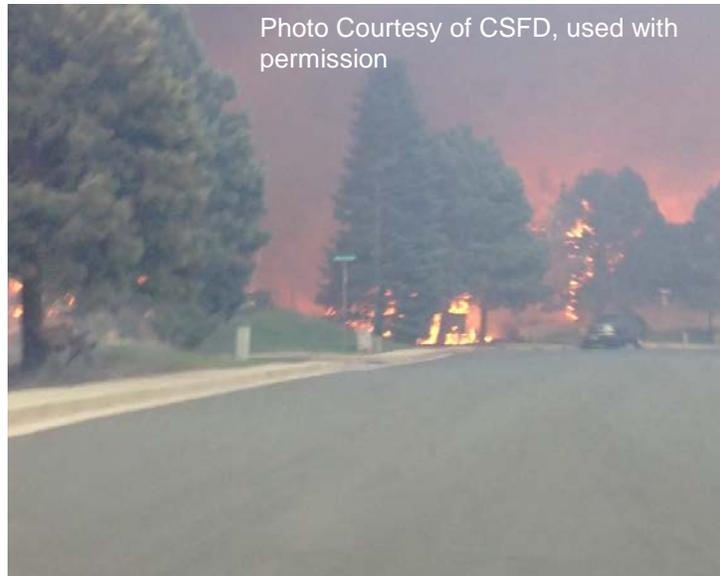
Figure 41 Image looking west into Majestic Drive from its northern entrance showing significant burning in the second cul de sac on the north side at 19:23.

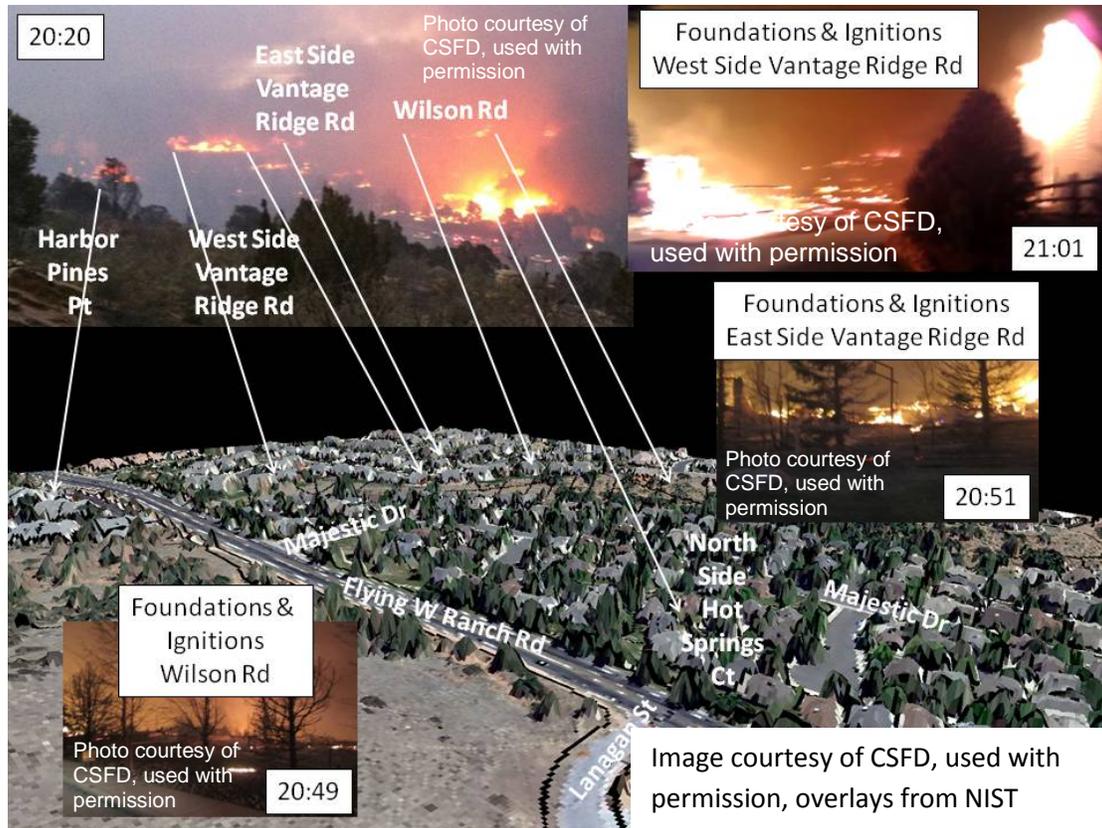
Figure 43 Selected images of burning primary structures around Majestic Drive.

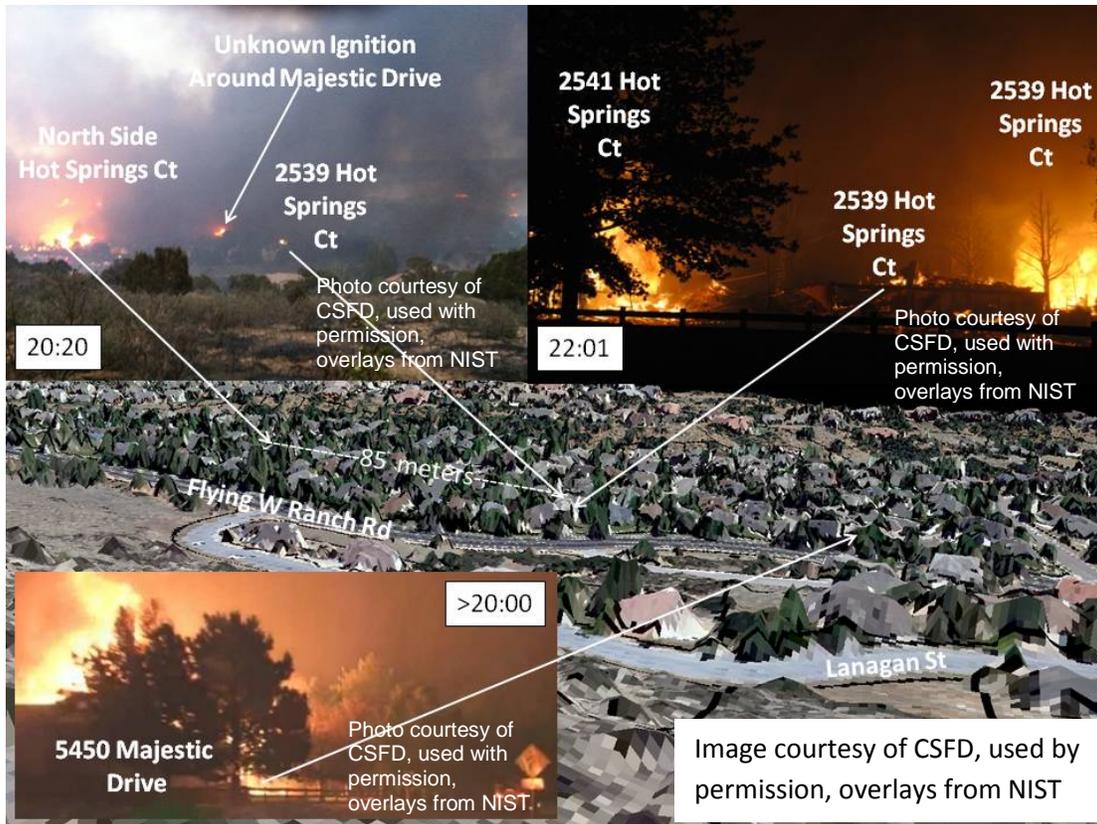
Figure 44 Additional selected images of burning primary structures around Majestic Drive.

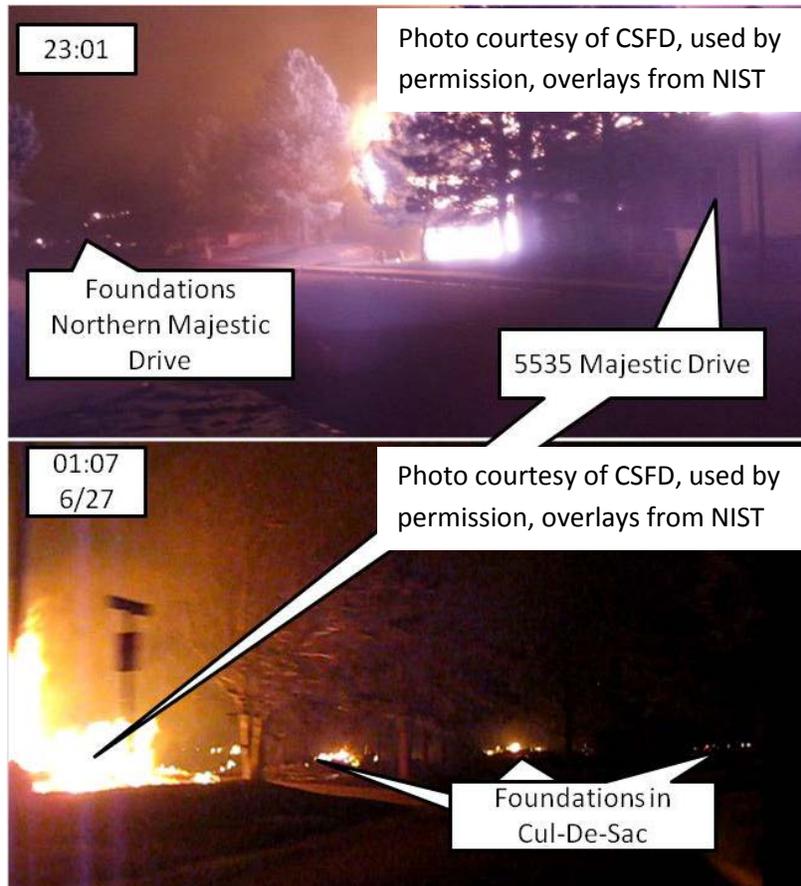
Figure 45 Ignitions on Majestic Drive providing evidence for majority of primary structures on east side ignited or destroyed by 23:00.

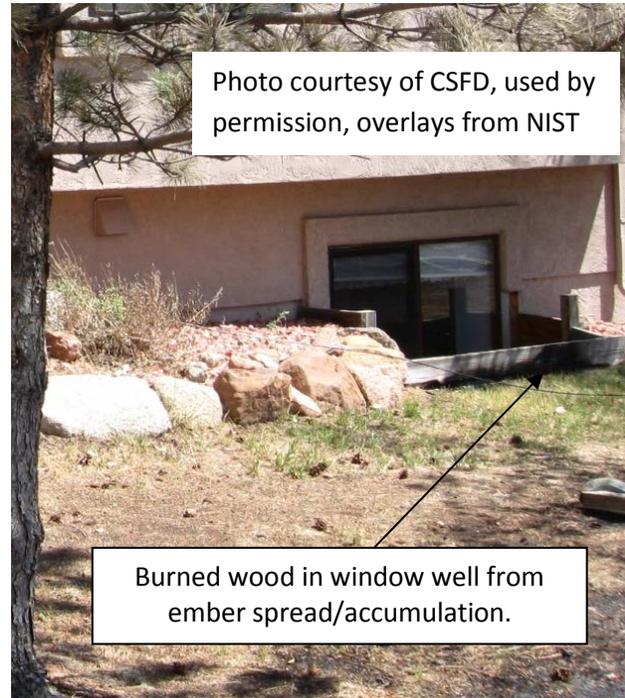
Figure 51 Damage to wooden window well. Note the damage was not from continuous fire spread as evidenced by the green vegetation.

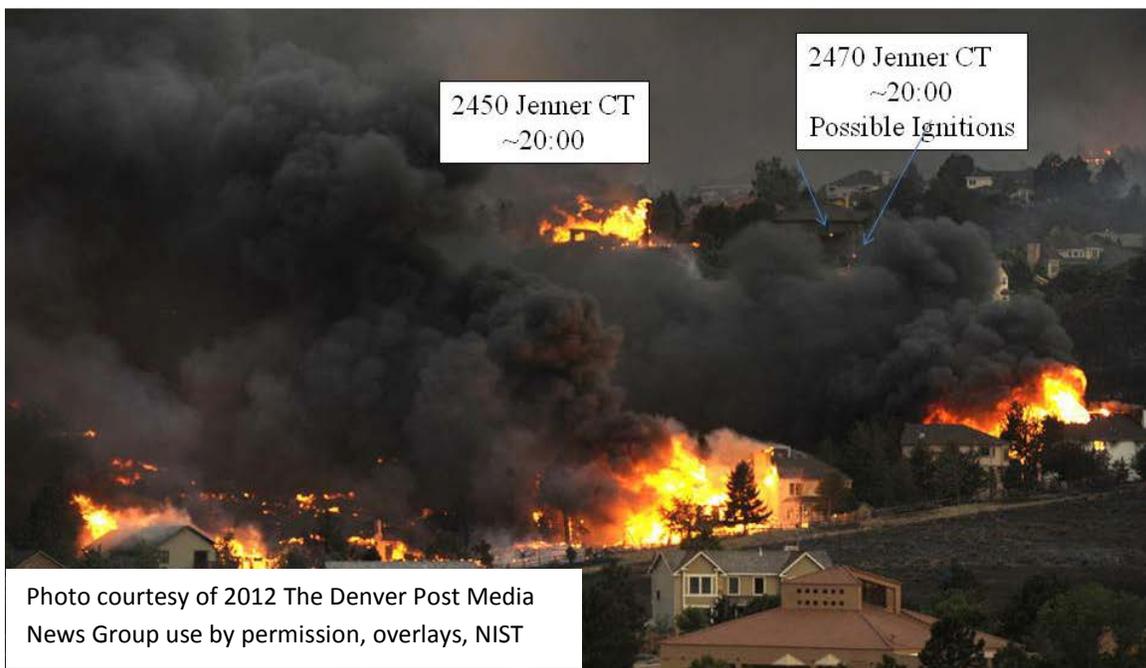
Figure 52 Possible ignitions at 2470 Jenner Ct in relation to burning at 2450 Jenner Ct.

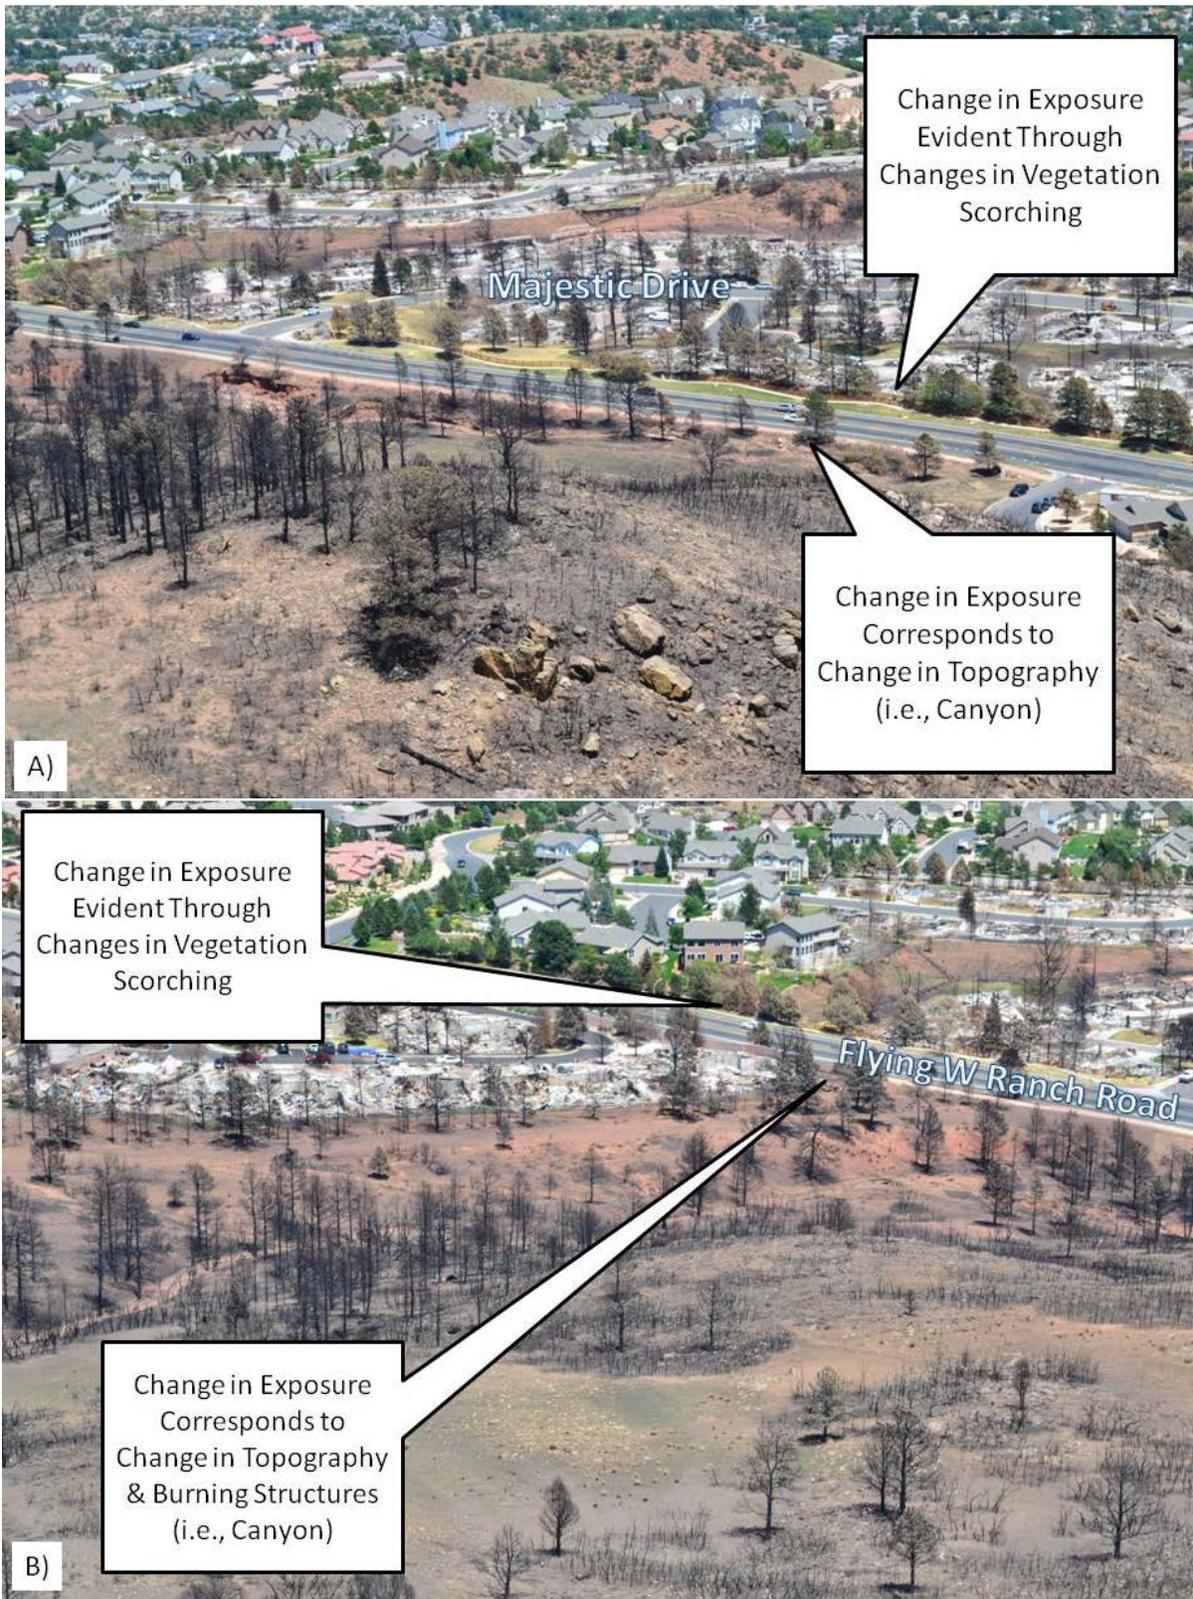
Figure 57 Changes in exposure conditions evident through changes in scorching to vegetation corresponding to areas across from a canyon and burning structures. Looking east to northeast. NIST Photos

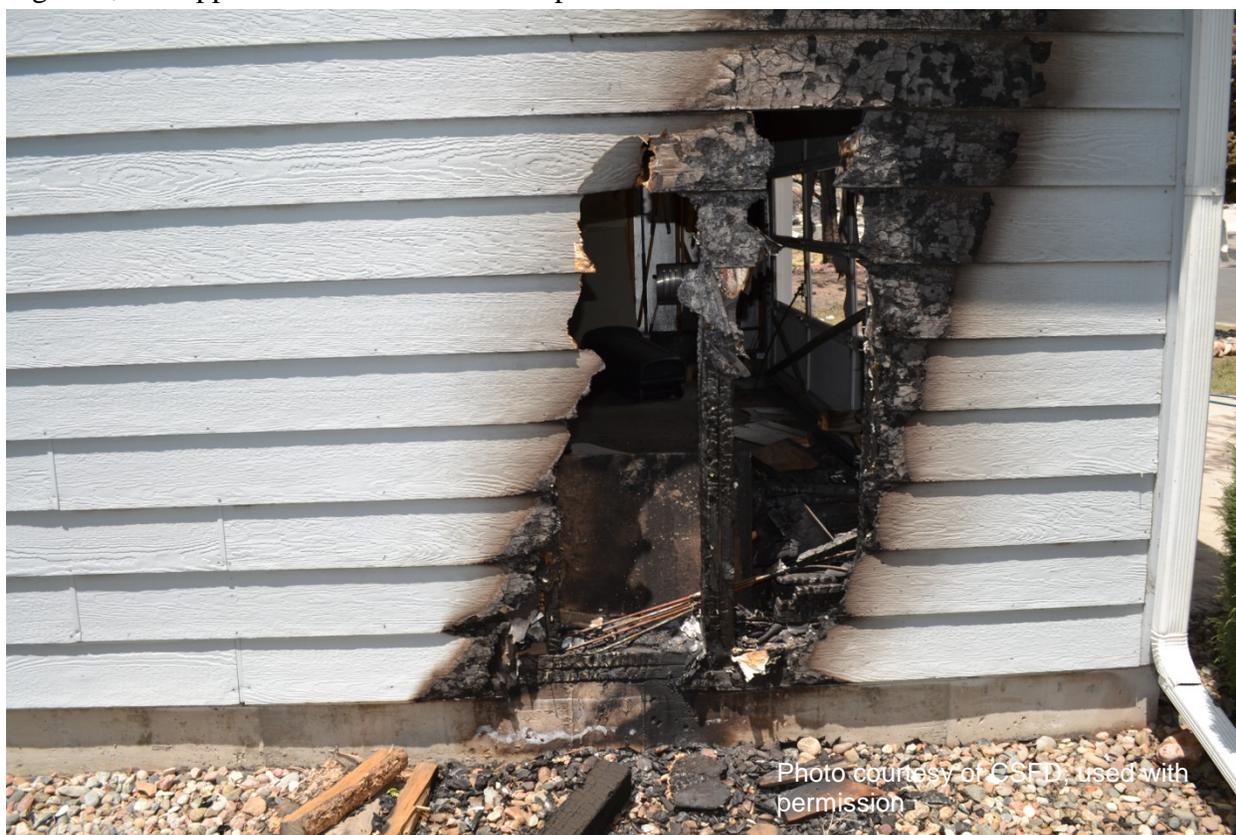
Appendix K Figure 1 Remnants of firewood pile, which appeared to have ignited and caused ignition of the composite lap siding and thereby entry into the garage. TDs identified first responders as breaking into garage and suppressing fire.
