NIST Technical Note 1910

A Case Study of a Community Affected by the Waldo Fire – Event Timeline and Defensive Actions

November 2015

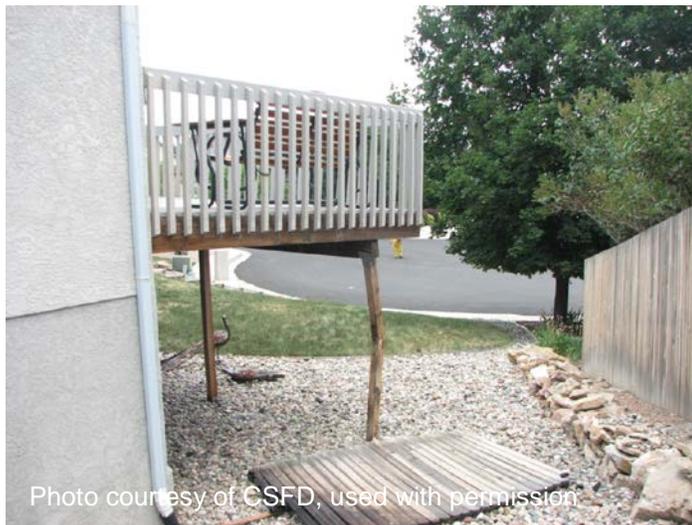
For example, Figure 5 portrays a primary structure with a damaged fence that might have been attached to the structure. The local damage collection protocol might include this type of damage as associated with the primary structure. The NIST data collection protocol used in this study considers fences as not attached, even if attached, to account for the common occurrence of the burning being relatively far from the structure. Data was not available to determine this distance. Additionally, the deck attached to the primary structure was damaged but with no evidence of the damage being from the fire directly. The NIST protocol is used in this report, and while the distinctions are arbitrary, they do point out the need for consistent protocols.

Figure 5 Image of a burned fence piece that appeared to have broken a deck post, which had no sign of fire damage.

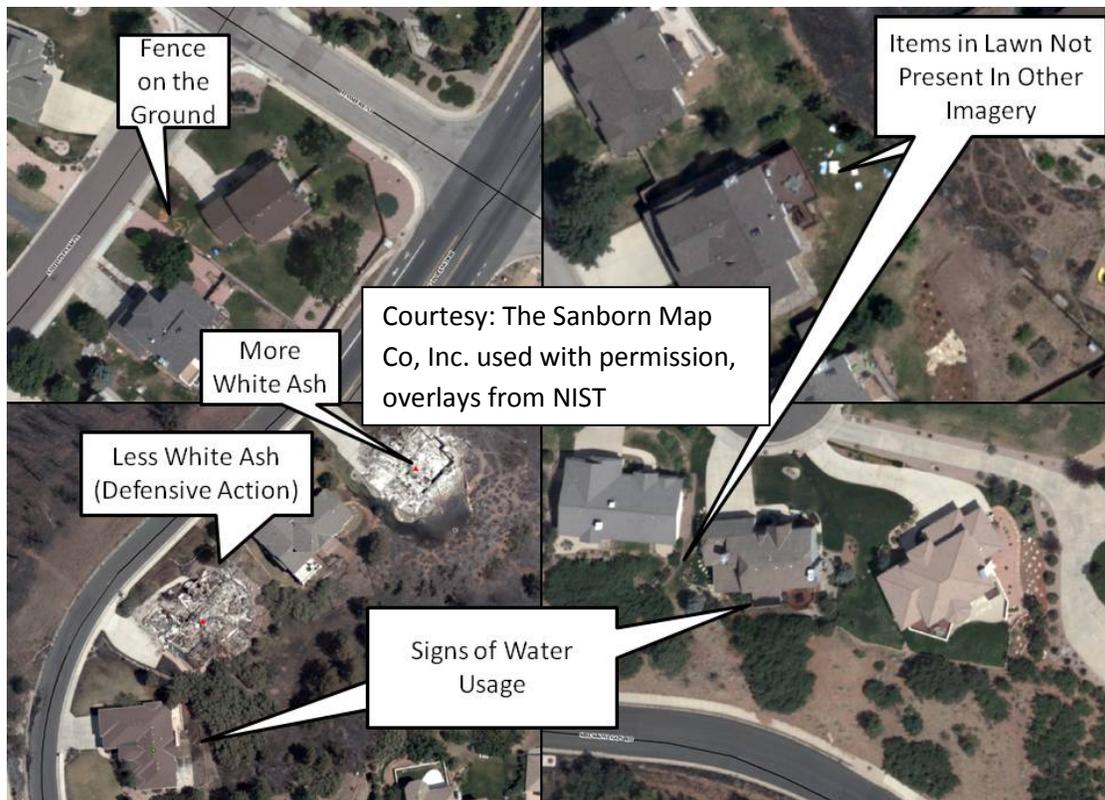
For example, Figure 9 shows the locations where there were signs of defensive actions not recorded through the TD process but visible in the remote sensing data. Shown in Figure 9 are the locations where fences were on the ground and debris was in the yard that was not present in pre-fire imagery or in post-fire imagery recorded on 7/12/2012, after homeowners had returned. Also, shown in Figure 9, not captured in the TD process, is a location with possible evidence of containment actions through lack of white ash on destroyed primary structures compared to adjacent destroyed structures. It should be noted, however, that the presence of white ash does not indicate that no defensive actions had occurred. Some containment actions, such as those on Hearthstone Lane, focused on spraying water on primary structures adjacent to the burning structure and did not result in a blackened appearance, yet fire spread was still contained.

Figure 9 Examples of remote sensing identified defensive action signs not identified during the TD process.

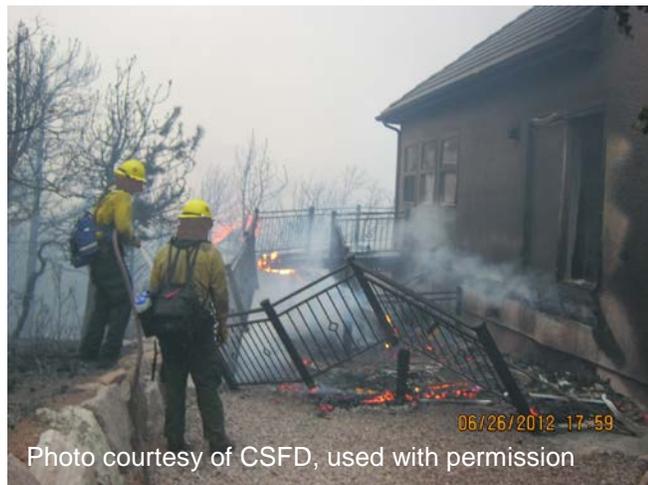
There was one image, shown in Figure 10, which required ground assessments to identify the location. Although even in this case, further confirmation was provided with Bing Maps and visual topographic analysis with the LidAR data (i.e., Line of Sight Analysis using the LP360 Extension to ArcGIS). Even in the dark, images of burning features were able to be geolocated if not blurry or over exposed. Nonetheless, the image shown in Figure 10 does highlight potential shortcomings of remote sensing technologies like Microsoft Bing Maps and Google StreetView for missing occluded features and features not viewable from the street.

Figure 10 Image of primary structure burning in the backyard that required ground assessment to geolocate.

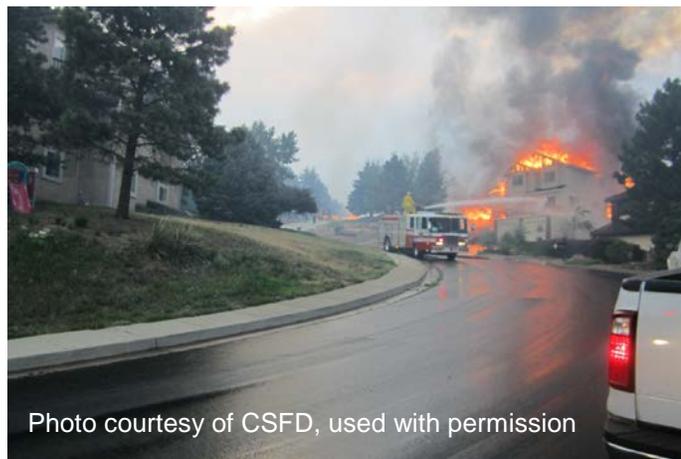
This same primary structure was identified by the image data team as a likely primary structure where fire spread was contained due to some type of suppression, despite initial results from the TD team indicating containment on the western structure. As shown in Map Figure 3, the eastern primary structure shows lack of white ash evidenced through blackened appearance, indicating lack of complete combustion of features. The exact cause of the blackened appearance ascertained from the post-fire imagery requires ground validation and, in this case, appeared to be contained by first responders with significant water application identified through the TDs.

Photo courtesy of CSFD, used with permission
Figure 13 Image showing significant engine work required to contain fire spread from burning primary structure.

The location of the containment action to the eastern primary structure is further confirmed by AVL locations clustered around 6045 Wilson Road, as shown in Map Figure 3. The AVL time stamp also indicates the action occurring around 21:00, over two hours after the white ash primary structure is shown as fully involved, as shown in the image contained in Map Figure 3 from a video taken by first responders. This image indicates the ignition order of the two primary structures as west to east, evidenced by the state of involvement of the structures. Structure-to-structure fire spread is not confirmed in this case as evidenced by burning of mulch in the foreground of the image shown in Map Figure 3, which might have ignited the structure on 6045 Wilson Road. Though there is some evidence of structure-to-structure fire spread through the presence of more white ash on the western side of 6045 compared to the eastern side.

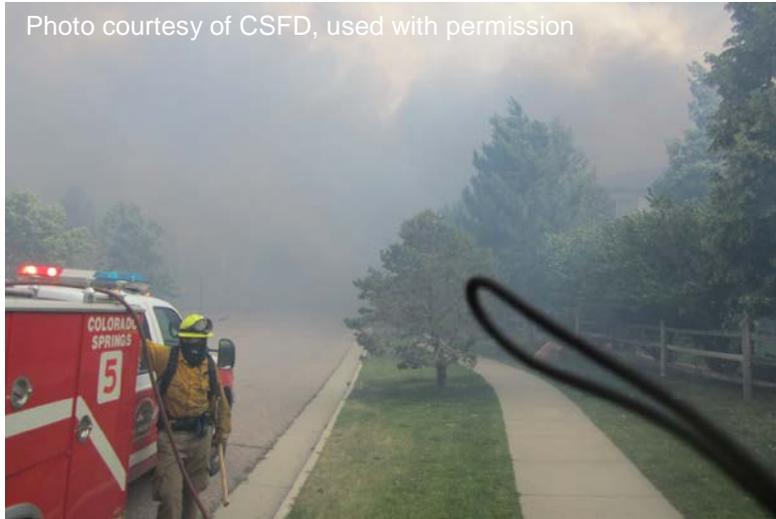
Figure 22 provides evidence of a possible defensive action around Wilson Road by a CSFD apparatus at 18:29. Although it is not conclusive that any action took place in this location, there is evidence that a defensive action might have occurred at this location based on the image of the first responder with equipment at the ready and the deployed hose. Ultimately, no defensive action was recorded at this location and time by the apparatus shown in Figure 22.

The area shown in Figure 22, which was geolocated due to Google Streetview imagery of the same location, is important to overall analysis of the Waldo Canyon Fire. Ideally, it is important to know what locations, built and wildland, received spotting potentially from the main wildland fire front. Aside from the image shown in Figure 22, there was no evidence of ignitions in this area after the passage of the main wildland fire front, though there was evidence of ignitions in areas to the south of this location. Consequently, uncertainty of ignitions is present based on the image shown in Figure 22, and the lack of a recorded defensive action in this location at the respective time.

Figure 22 Image taken at 18:29 on Wilson Road to the east of Vantage Vista Drive showing an unconfirmed defensive action.

recording defensive action information. For example, if a crowd sourcing method was available to gather information from first responders, the image shown in Figure 22 could have been used before the TDs began. This would have allowed data recorders the opportunity to present the image to first responders on the apparatus, which might have refreshed the memory of the responder to the action that took place.

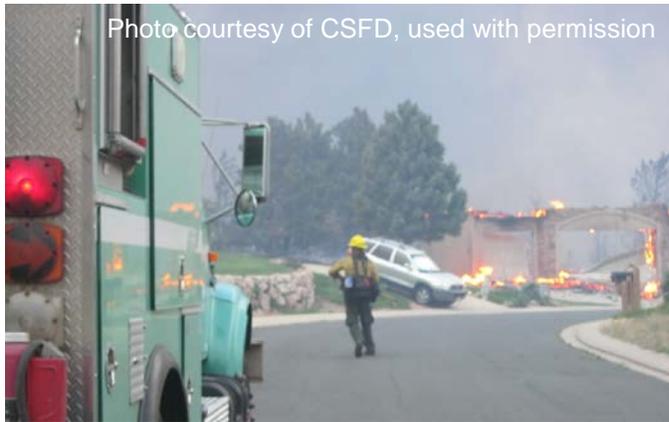
Figure 35 Image of primary structure on Talleson Court taken at 19:11 on June 26, which allowed time stamp observations for other primary structures not shown to be obtained.

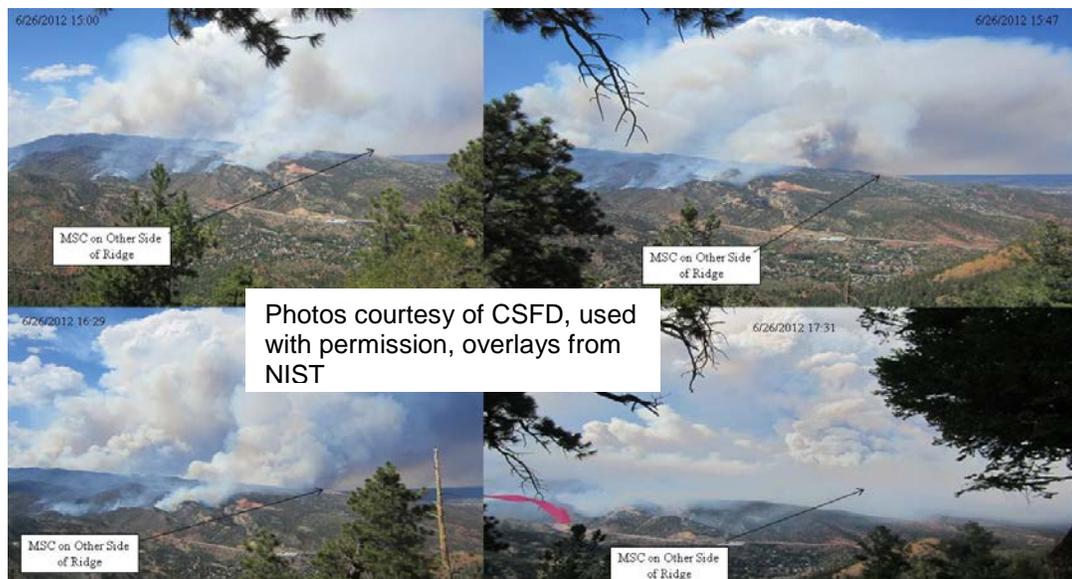
Additionally, there appeared to be intense fire behavior in the canyon area to the west of MSC with a pyrocumulus cloud moving along this canyon generally from west to east, as shown in Figure 36. The images in Figure 36 were recorded by first responders assessing the fire as it was approaching Cedar Heights and show the smoke plume as the fire travels down the canyon to the west of MSC. There are no images, available for this report, of fire in the canyon to the west of MSC.

Figure 36 Pyrocumulus cloud as it approaches MSC from the west. Observed from south of Cedar Heights Community on June 26 at approximately 17:00.

The plume approached MSC from the west, then started leaning or collapsing in the vicinity of the Wilson Road water tower between 17:20 and 17:25. First responders were evacuated from MSC at 17:23 when the fire was approaching various locations along the MSC wildland interface. Visibility near the water tower was reduced to less than 10 m (33 ft) with strong winds and heavy ember showers. Table 12 summarizes the first responder observations from just prior to right after the evacuation to Chipeta Elementary. Embers reported from TDs were up to “fist” size from the Water Tower off Wilson Road all the Way to Chipeta Elementary. During the first stage of the evacuation to Chipeta Elementary, visibility improved near Flying W Ranch Road.

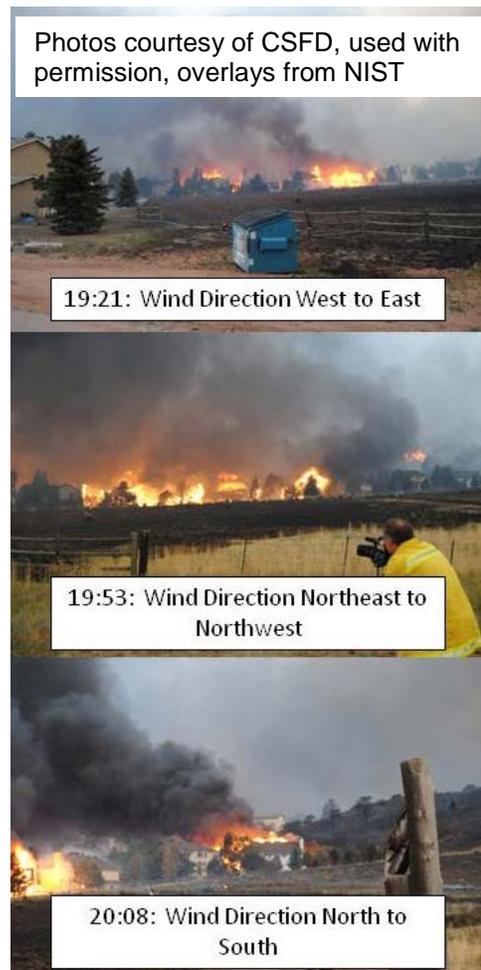
Figure 37 Time lapse imagery portraying change in wind direction on Courtney Drive. Images are looking south.

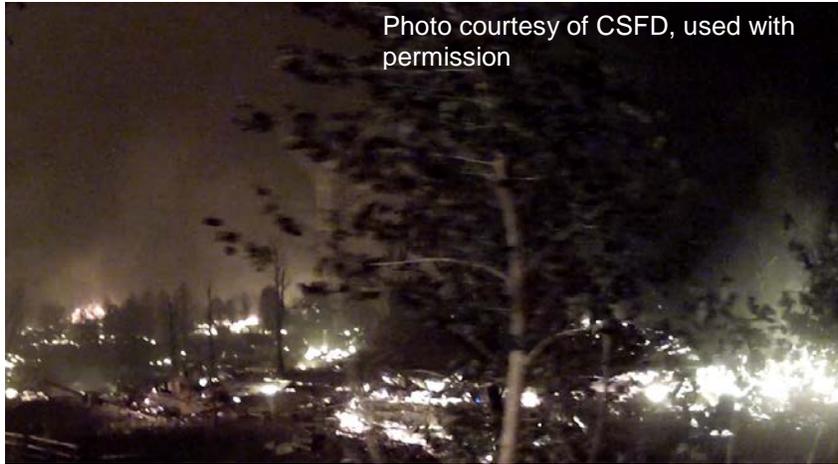
Figure 42 portrays a single screen shot from a video showing the structures on the north end of Majestic Drive as foundations sometime between 20:45 and 21:15. This is further evidence that the primary structures on the northern end of Majestic Drive were destroyed or ignited before 20:30. Additional evidence is also provided in Figure 43, which highlights various burning and non-burning areas. Also shown in Figure 43 are multiple ignitions in the northwestern area of Vantage Vista Drive, labeled as unknown ignition status in Map Figure 25.

Figure 42 Destruction on the north end of Majestic Drive observed between 20:45 and 21:15.

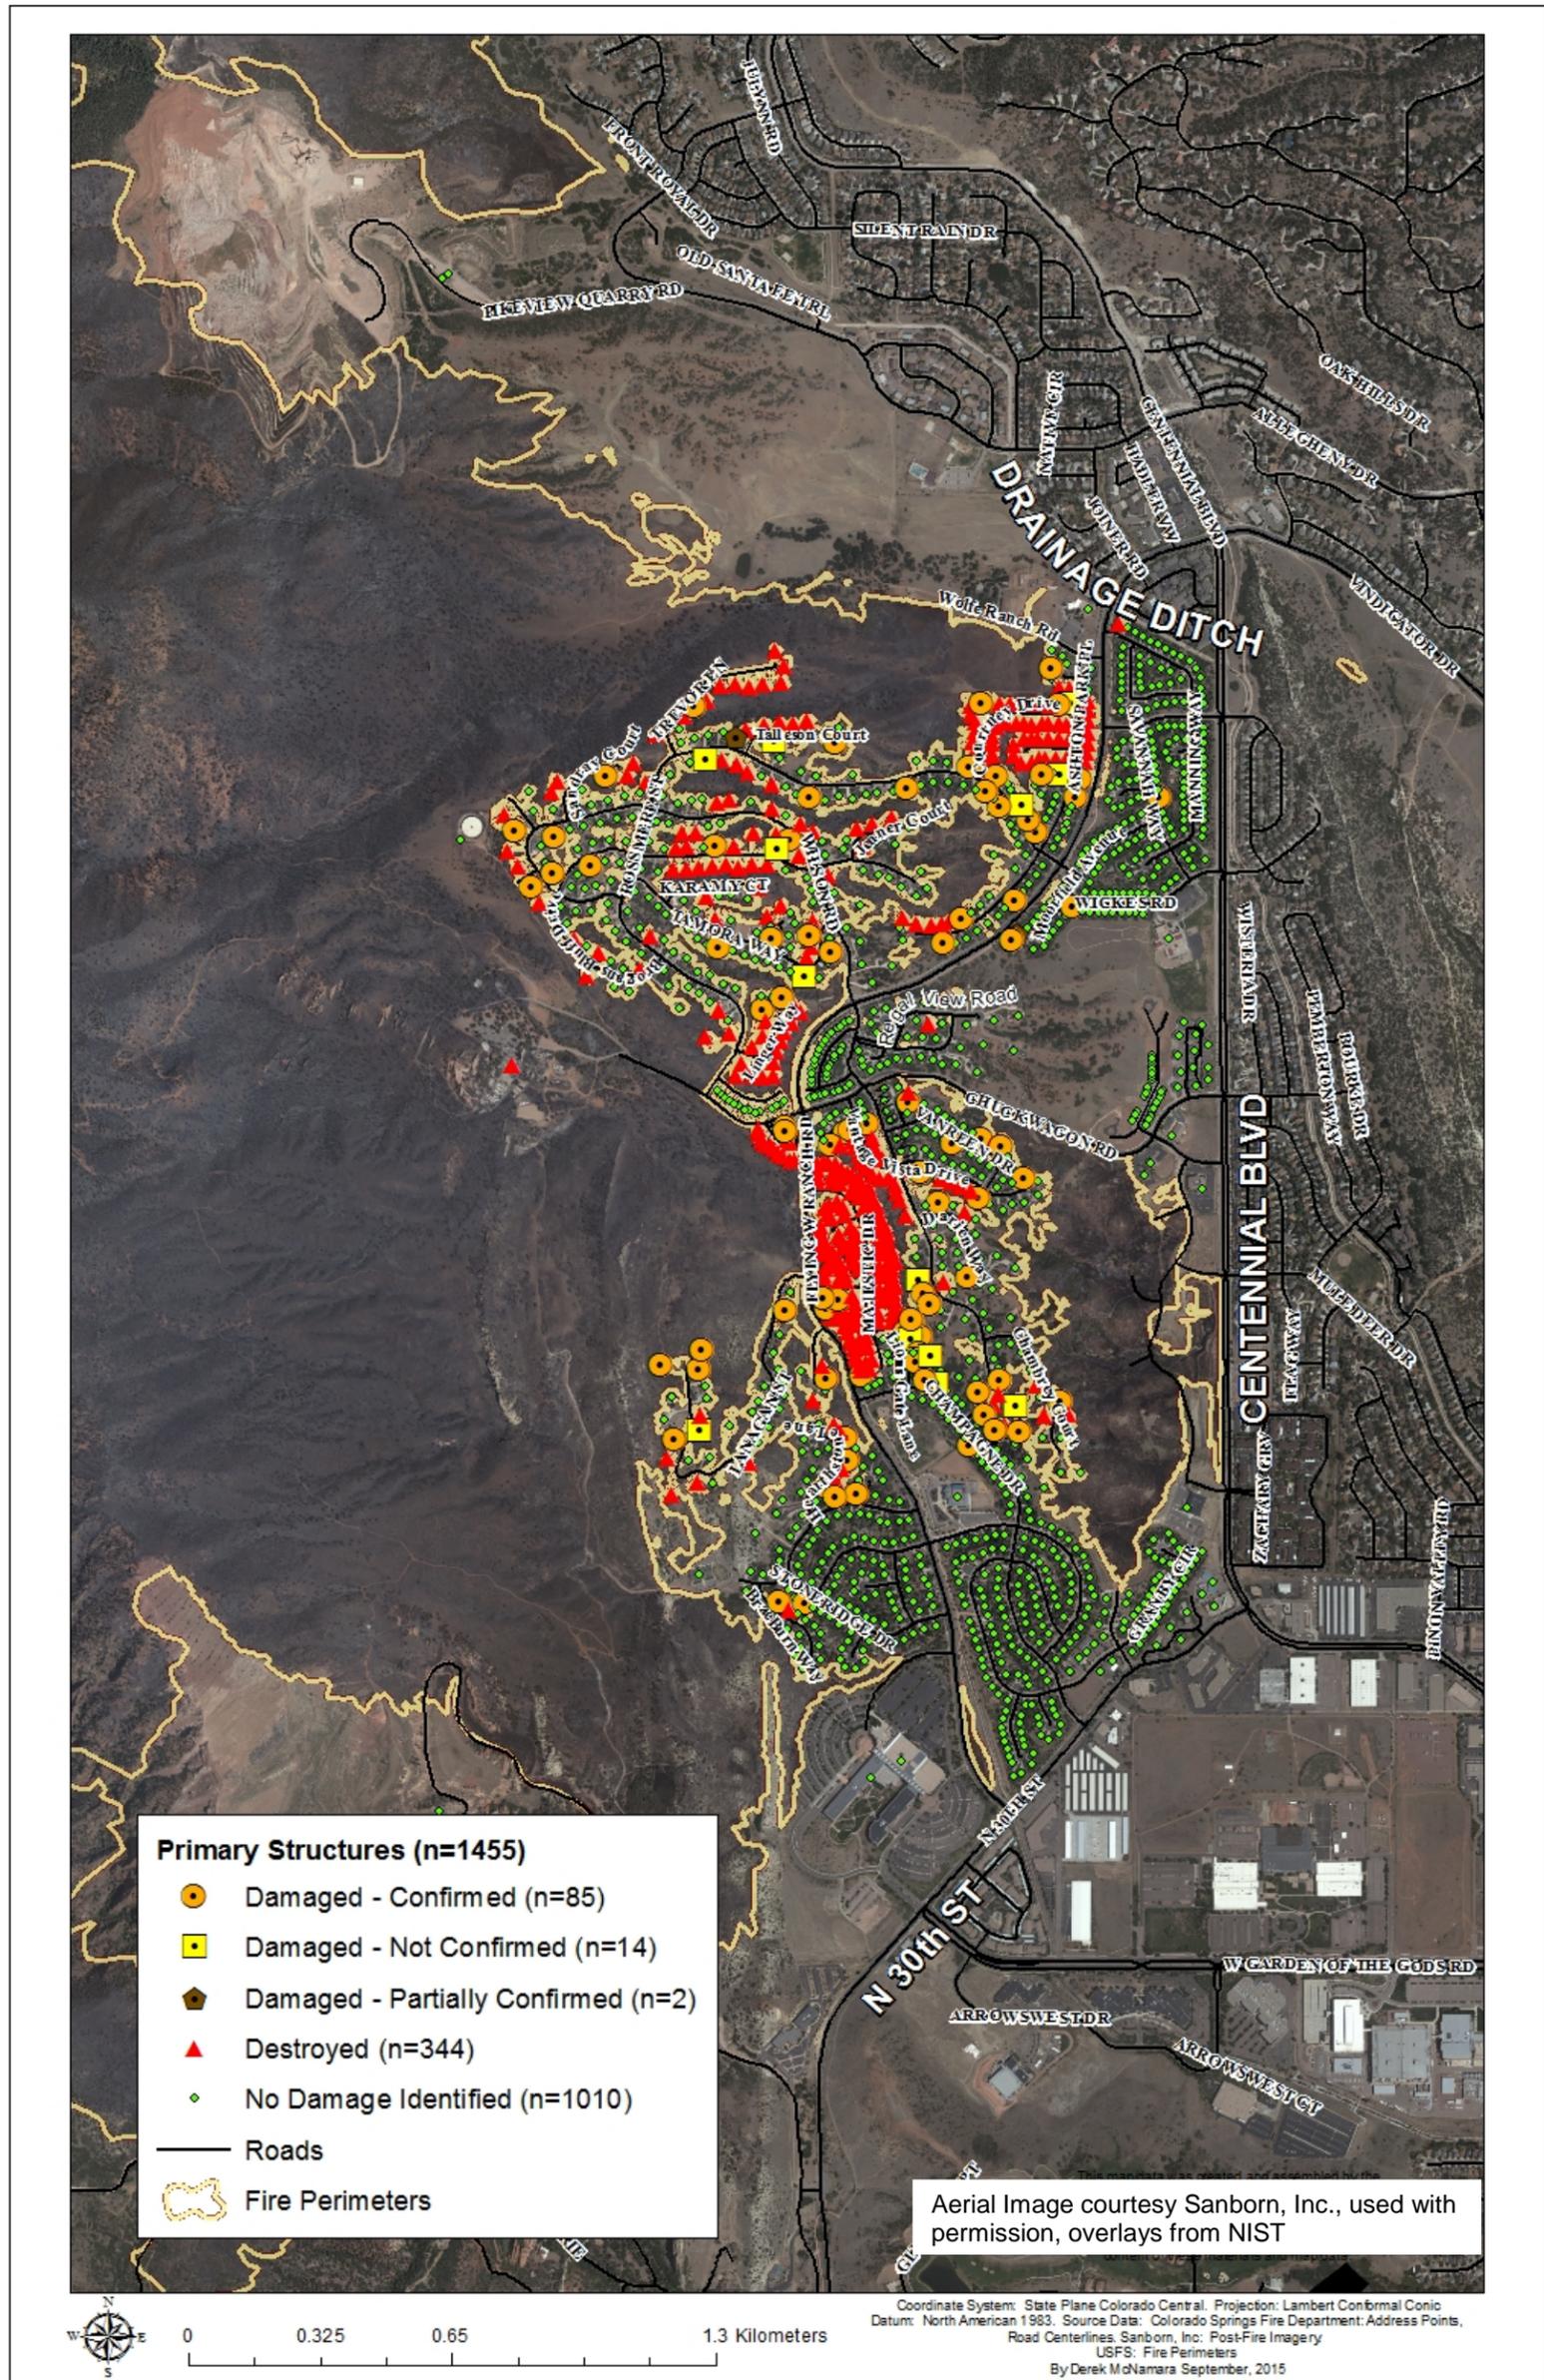
Map Figure 2 Overview of destruction to MSC by 2012 Waldo Canyon Fire.

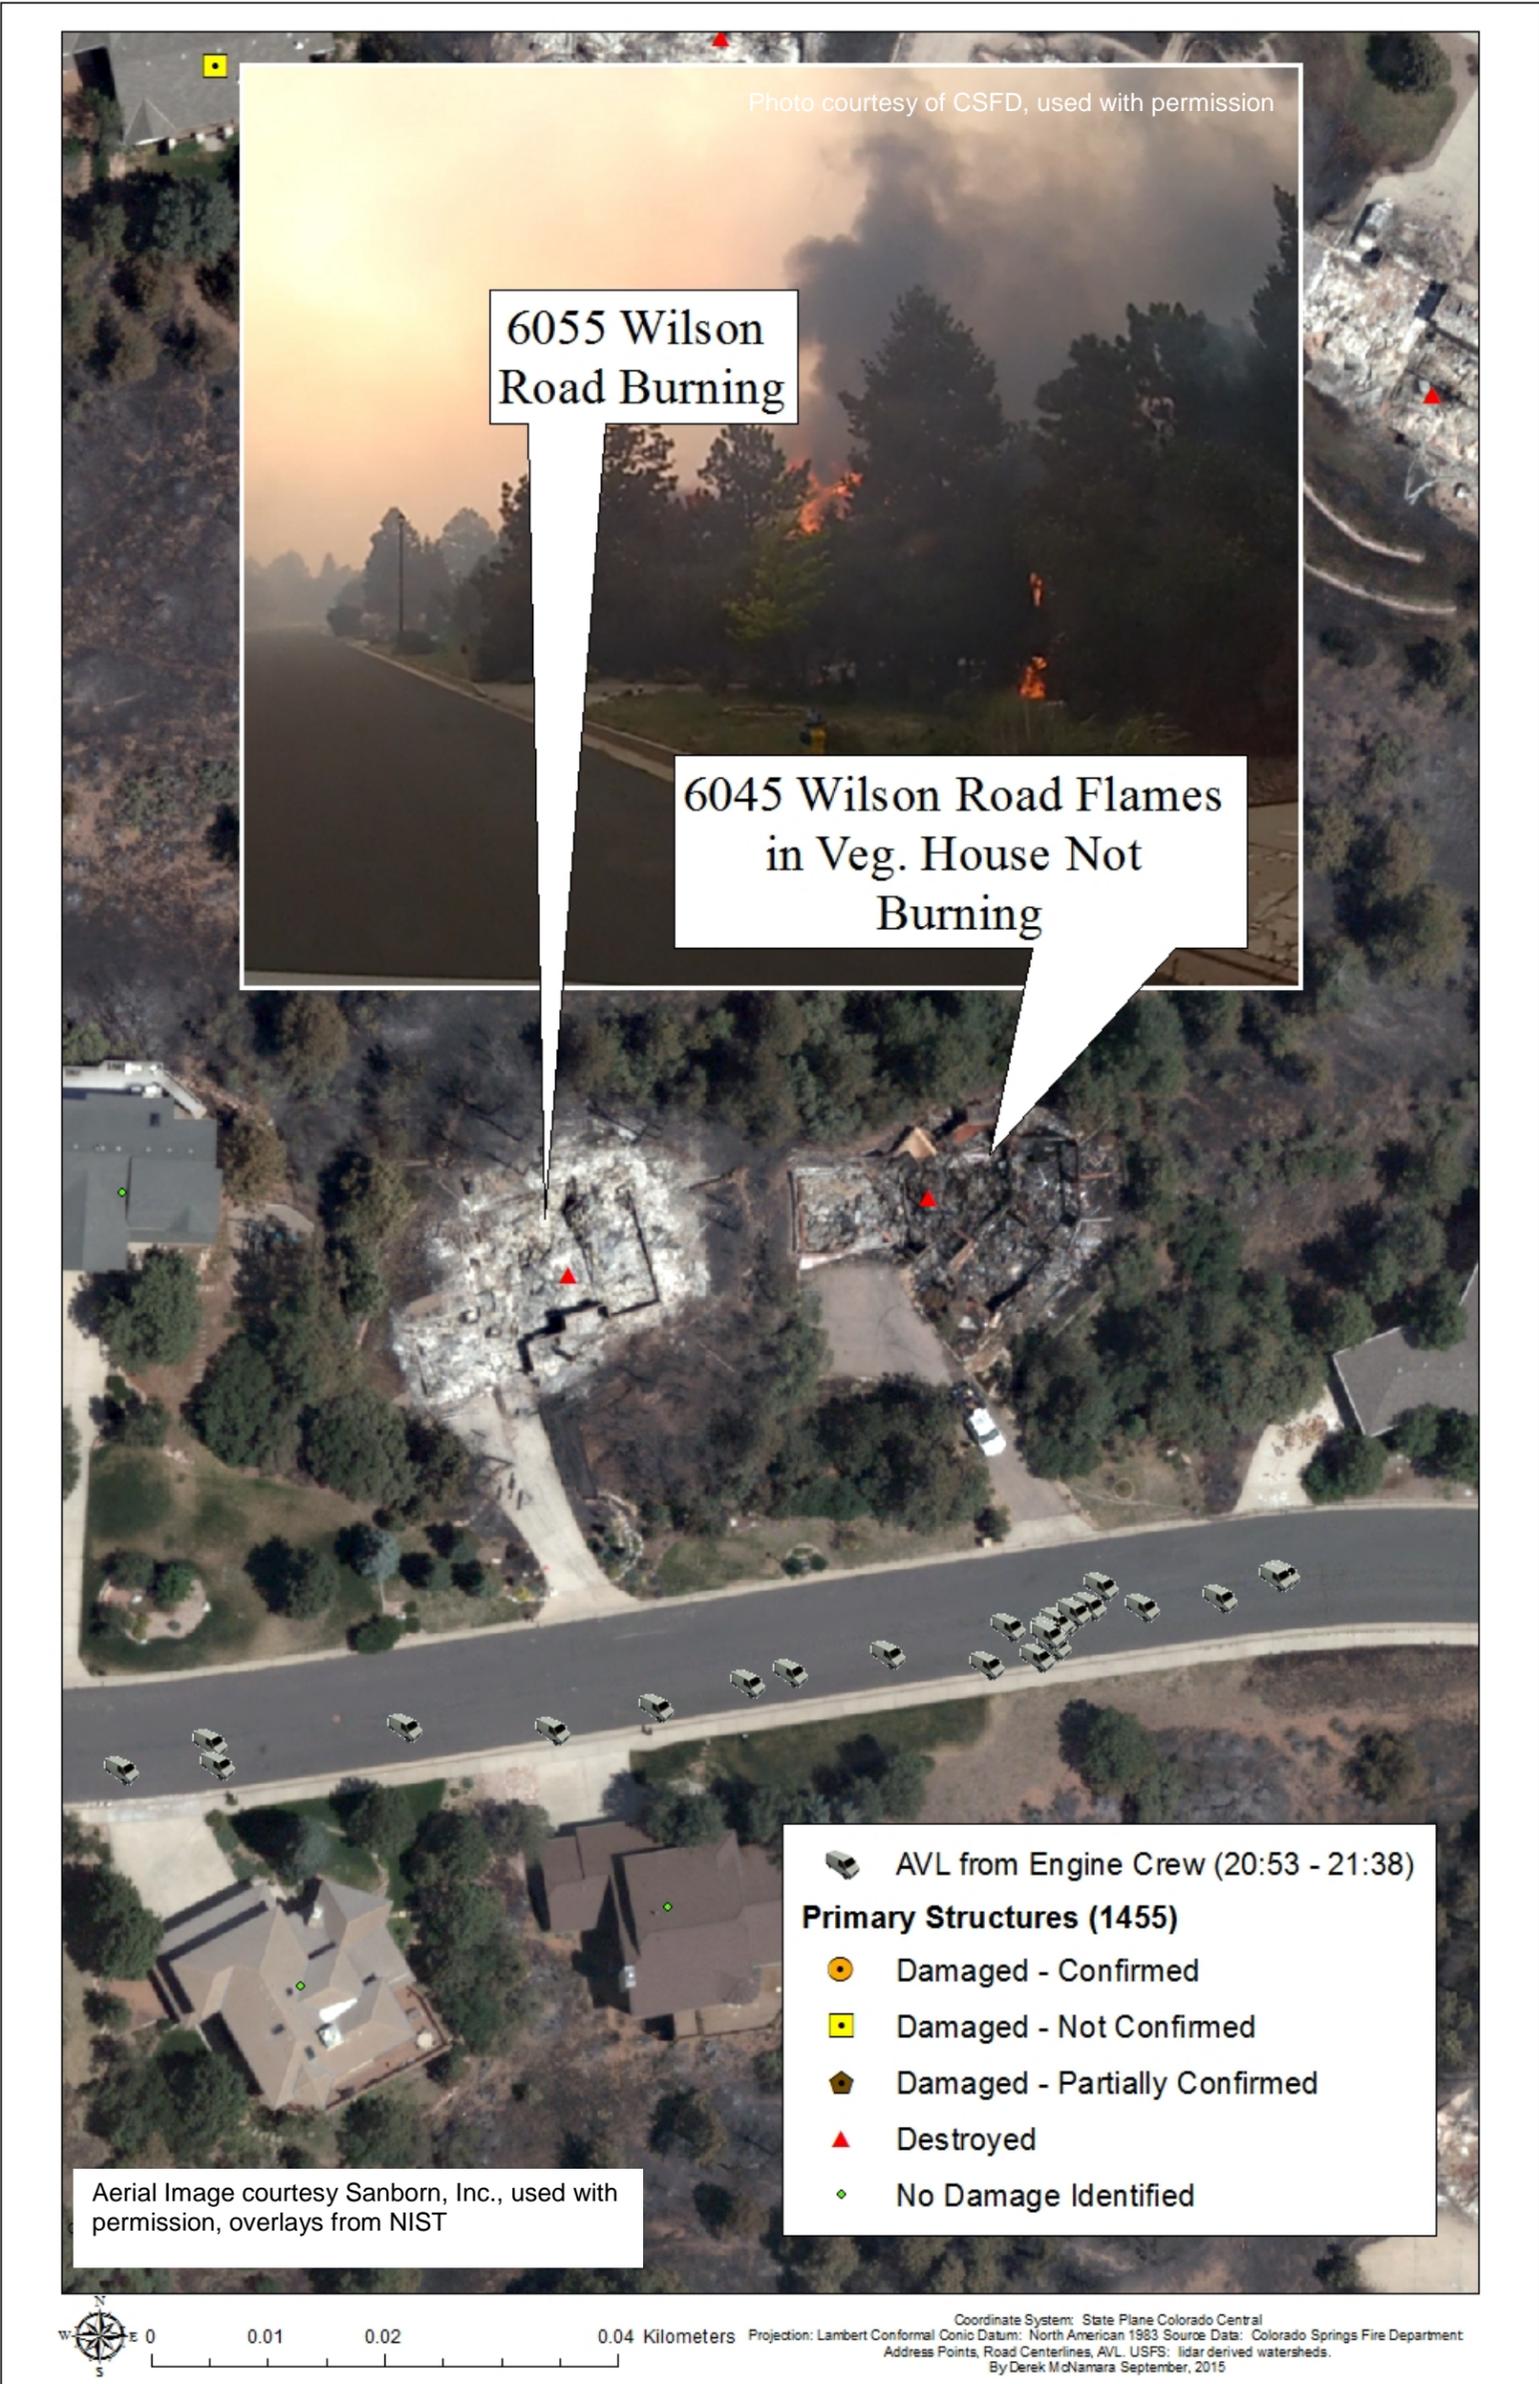
Map Figure 3 Location of two destroyed primary structures including images showing burning of western structure and locations of Engine from AVL clustered around primary structure with lack of white ash indicating lack of complete combustion of features.

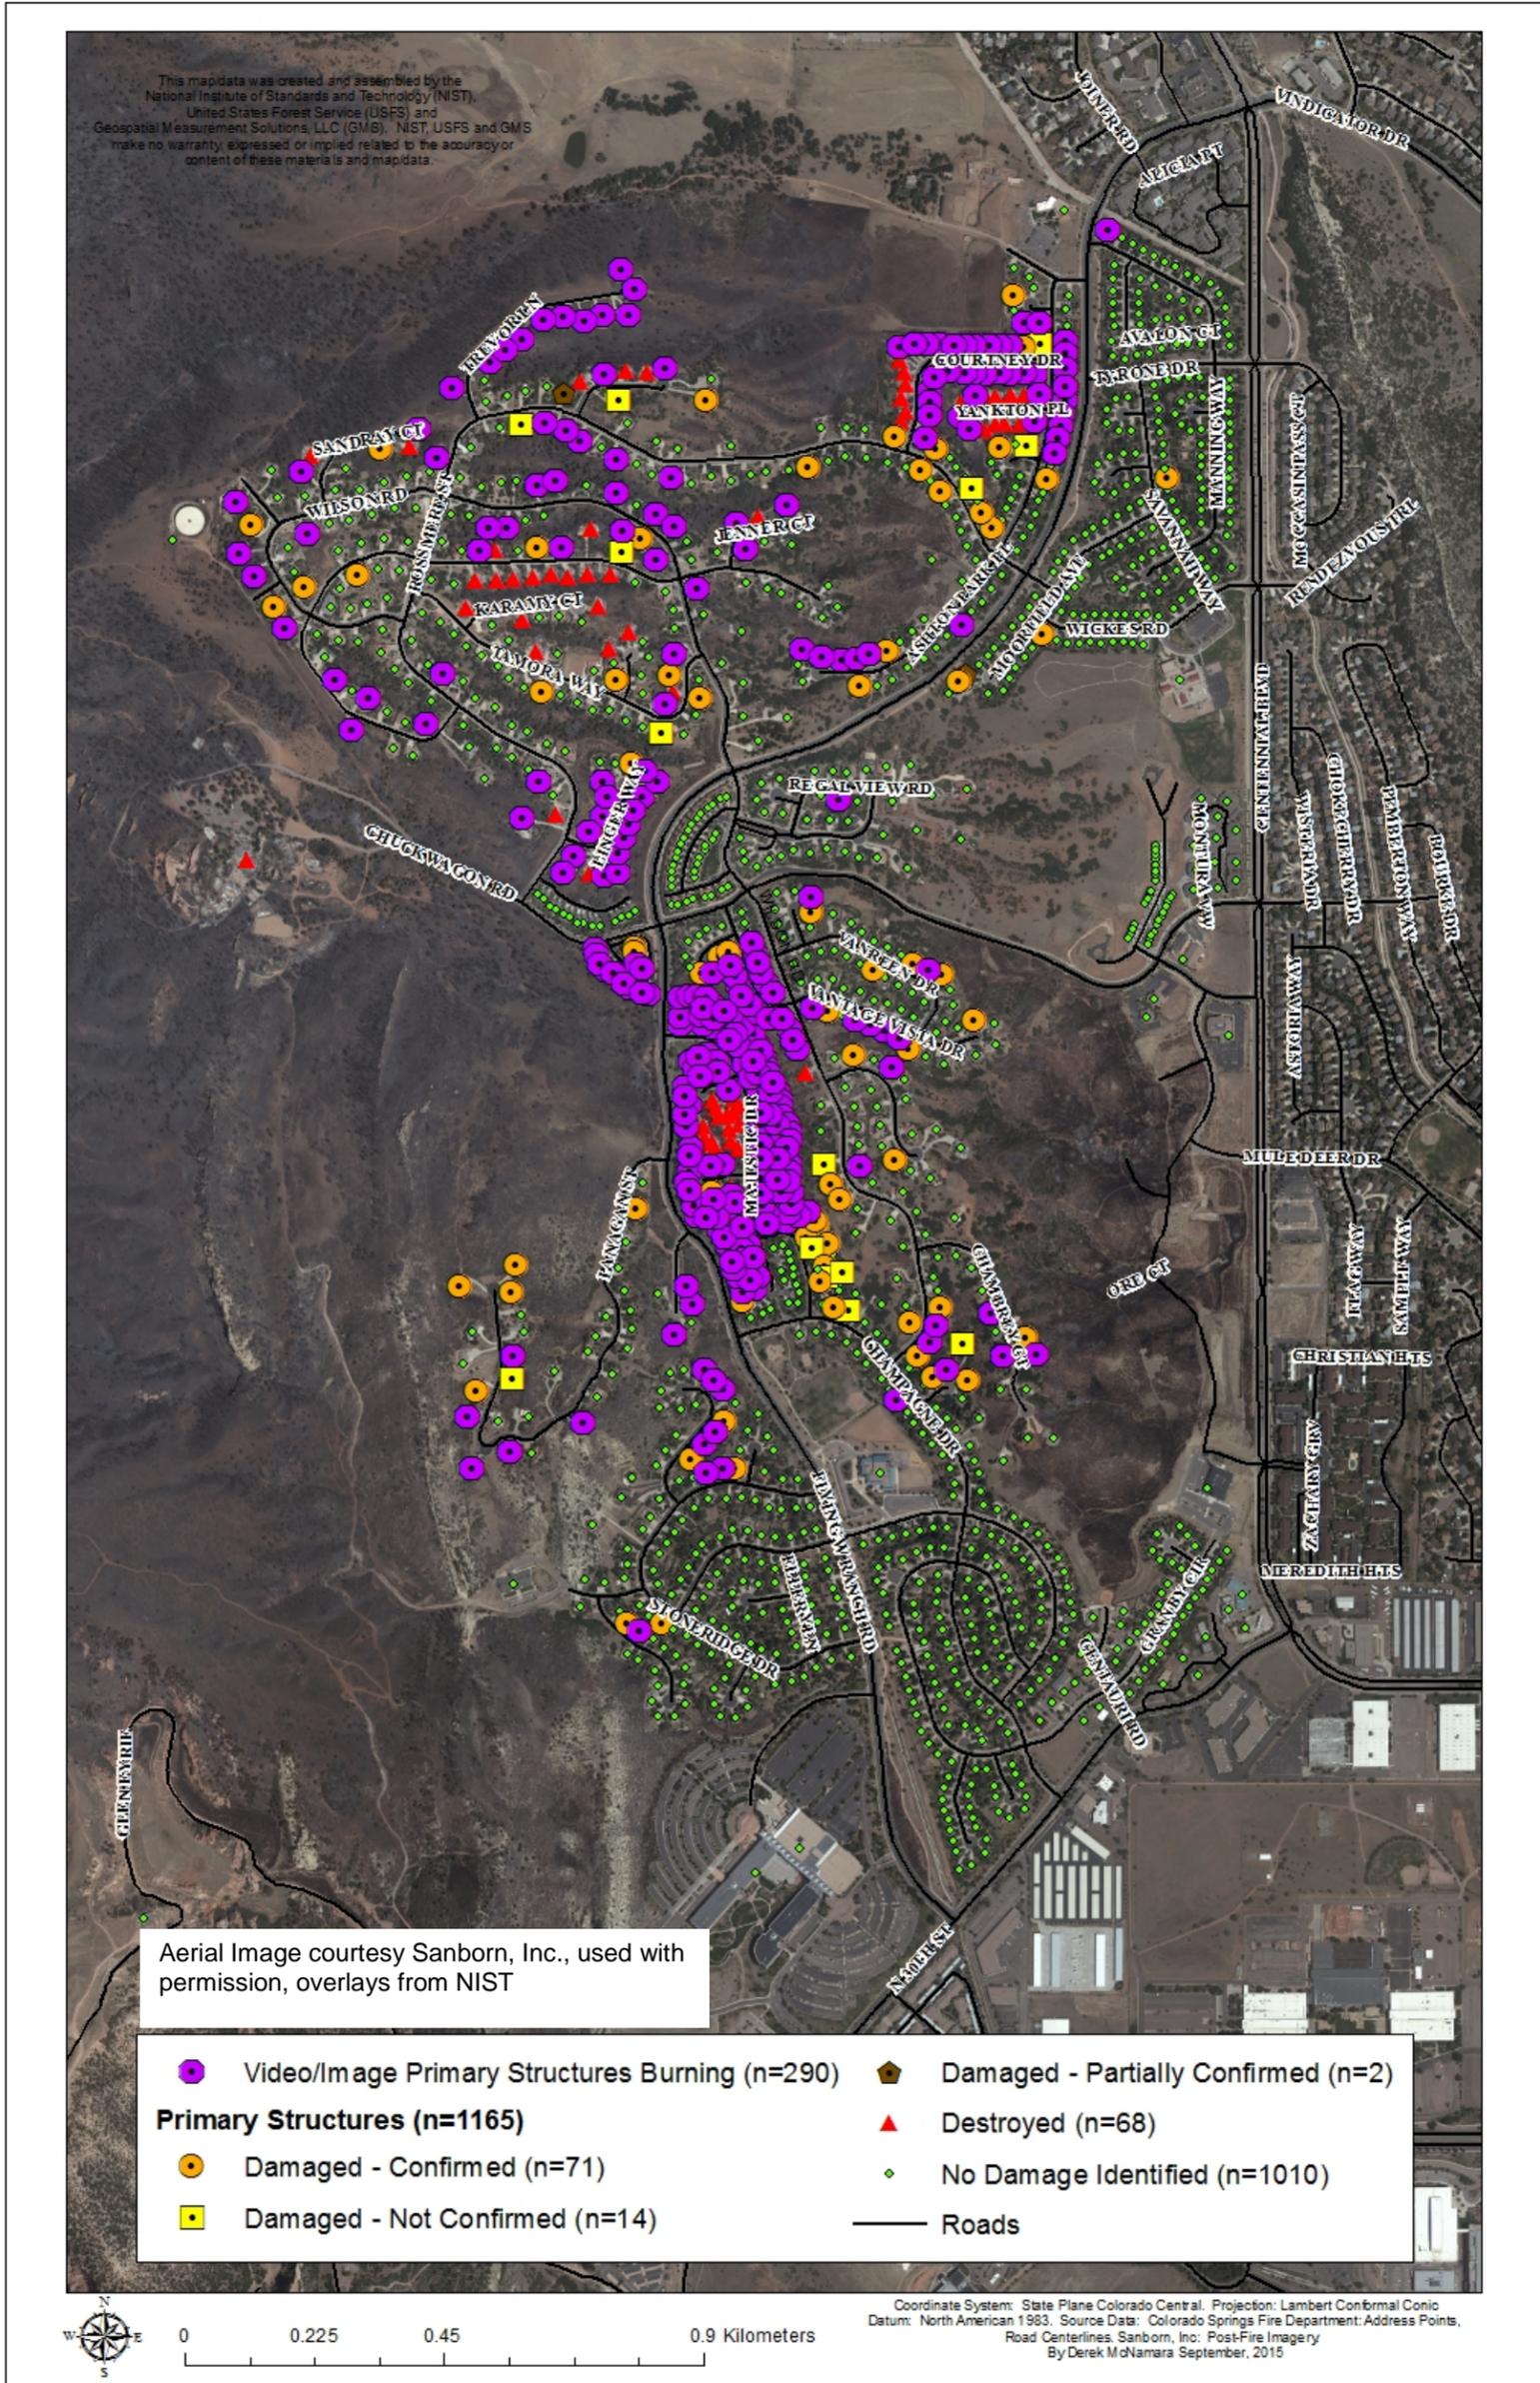
Map Figure 4 Destroyed and damaged structures with some video or image recorded of it in some state of burning, including complete destruction between 6/26/2012 17:59 to 6/27/2012 01:30.

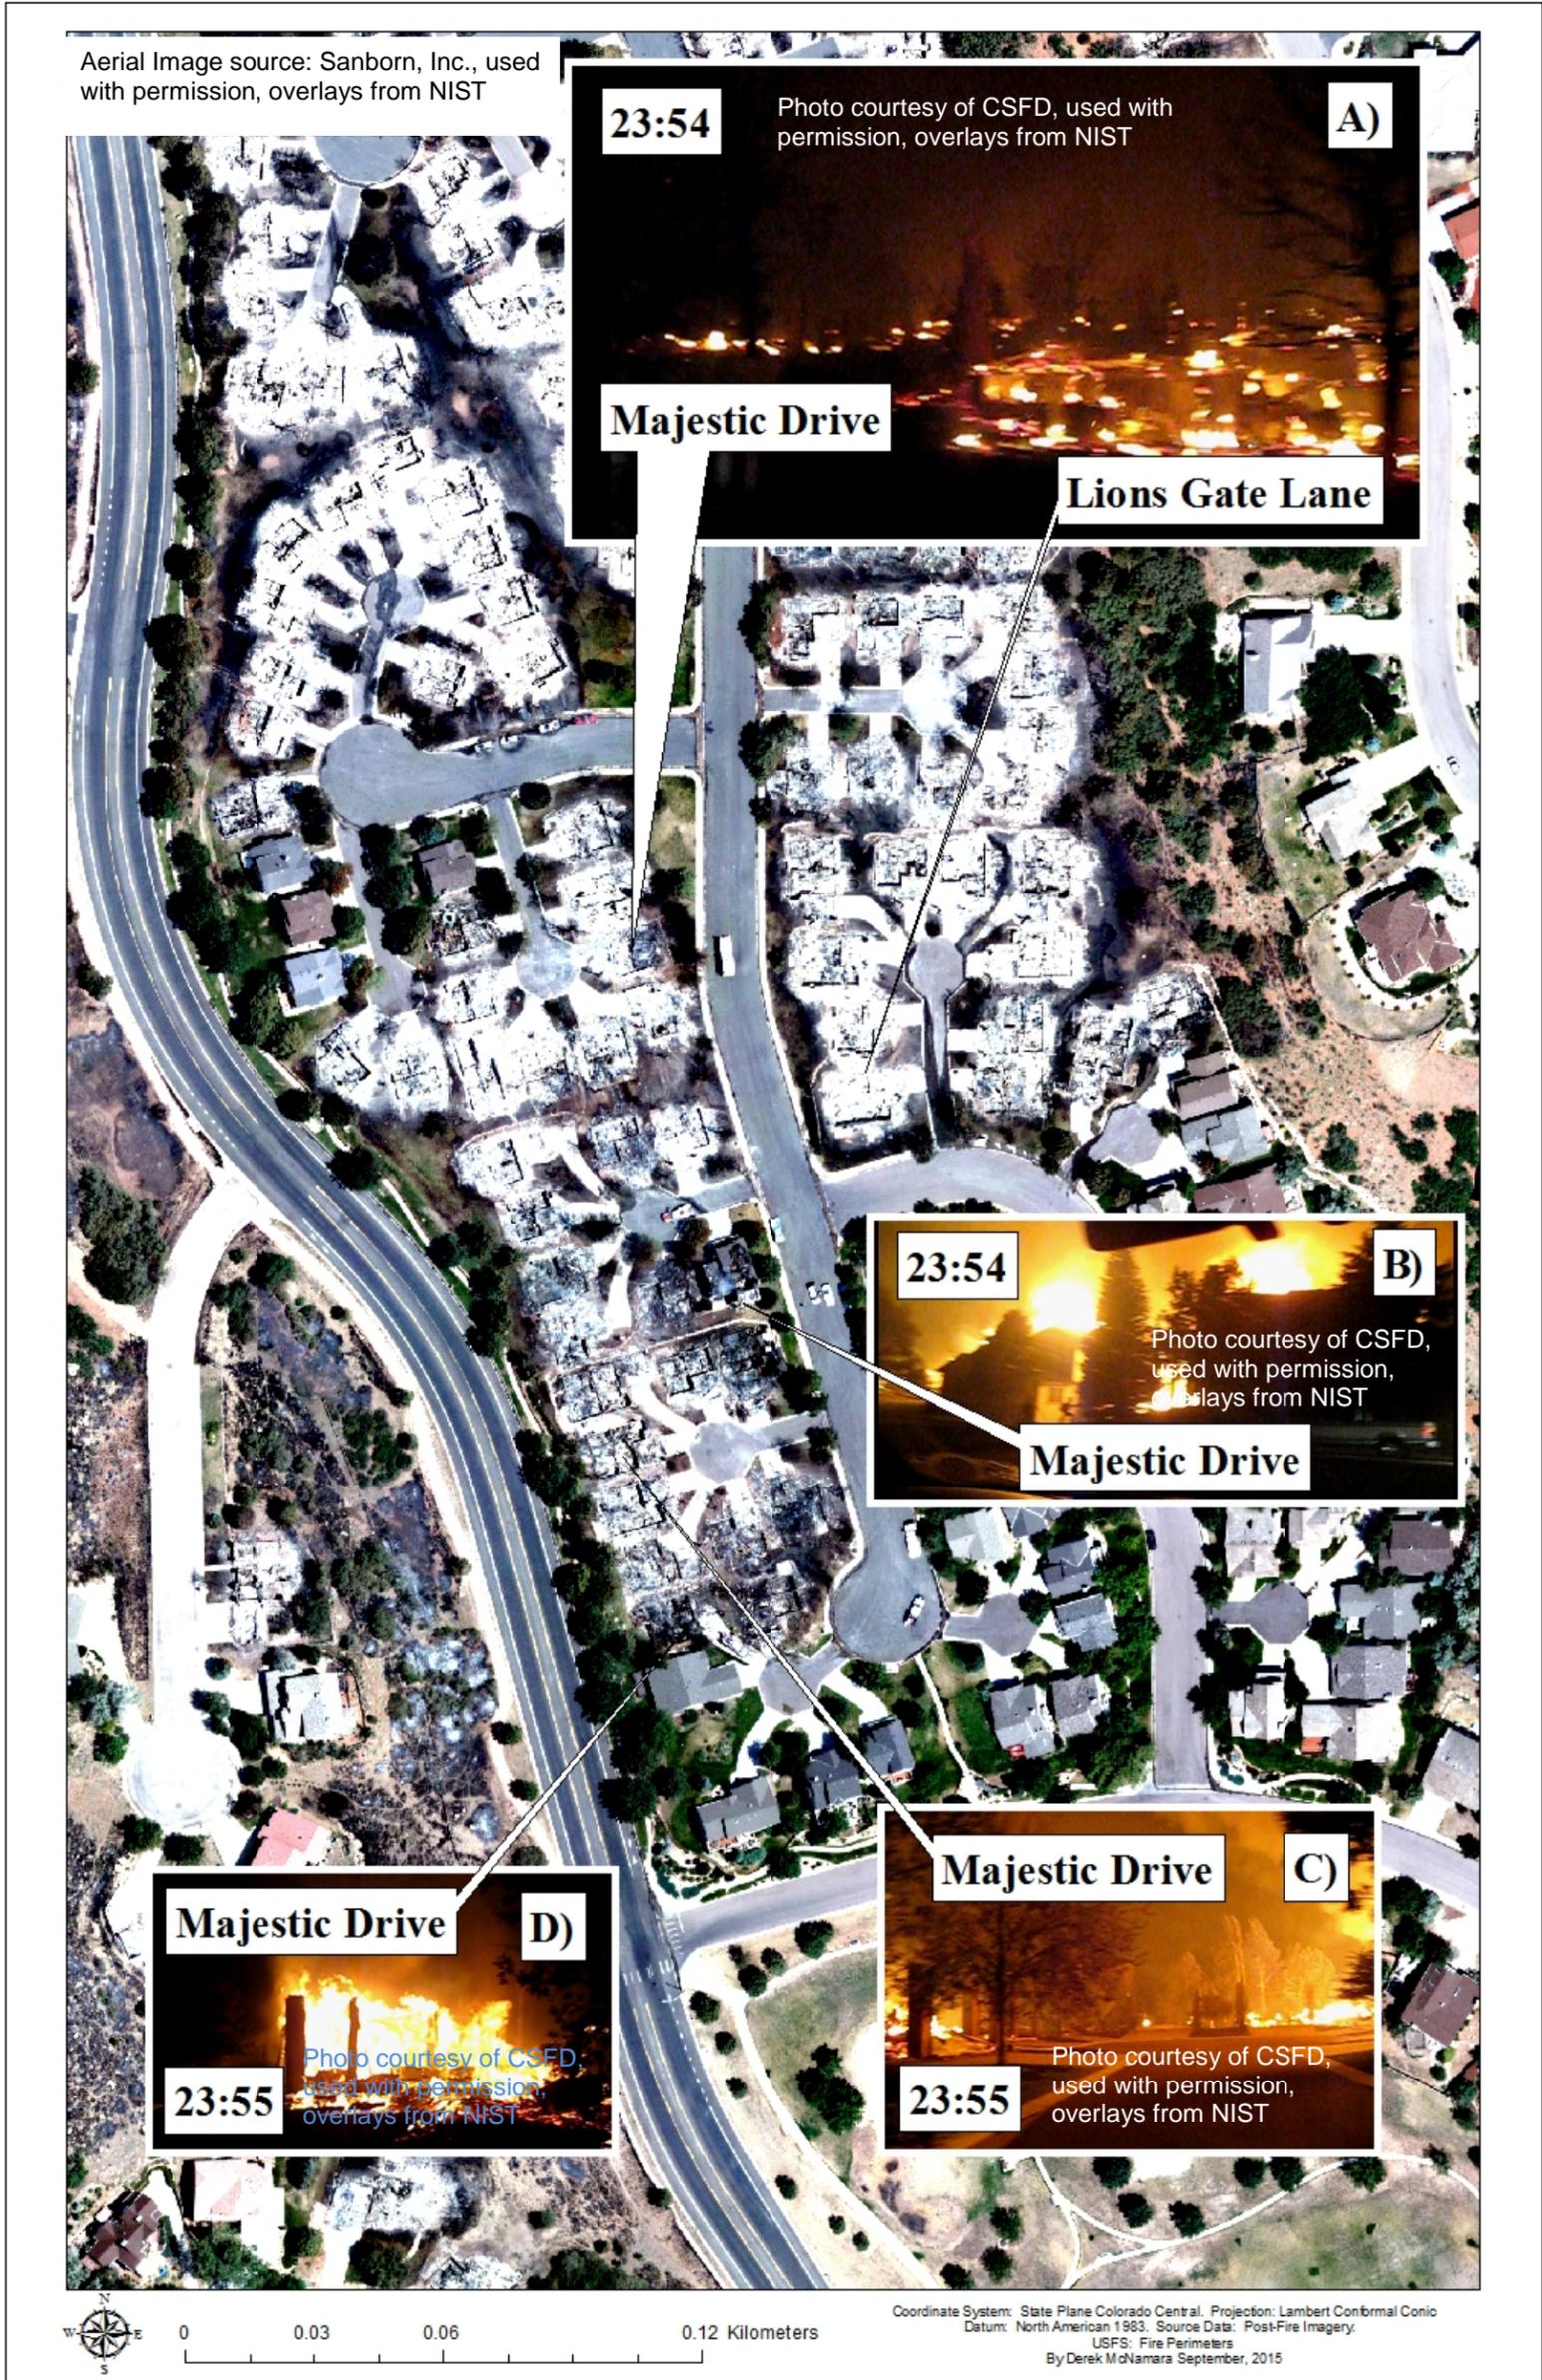
Map Figure 27 Images of structures as foundations or fully involved before 23:55. Image B and Image D show some of the last structures to burn in the area along with defensive actions. Defensive actions and burn order can also be deduced from areas with lack of white ash as shown in image C that indicates structures as foundations before successful containment actions occurred coinciding with structures containing white ash.
