NIST Technical Note 1910

A Case Study of a Community Affected by the Waldo Fire – Event Timeline and Defensive Actions

November 2015

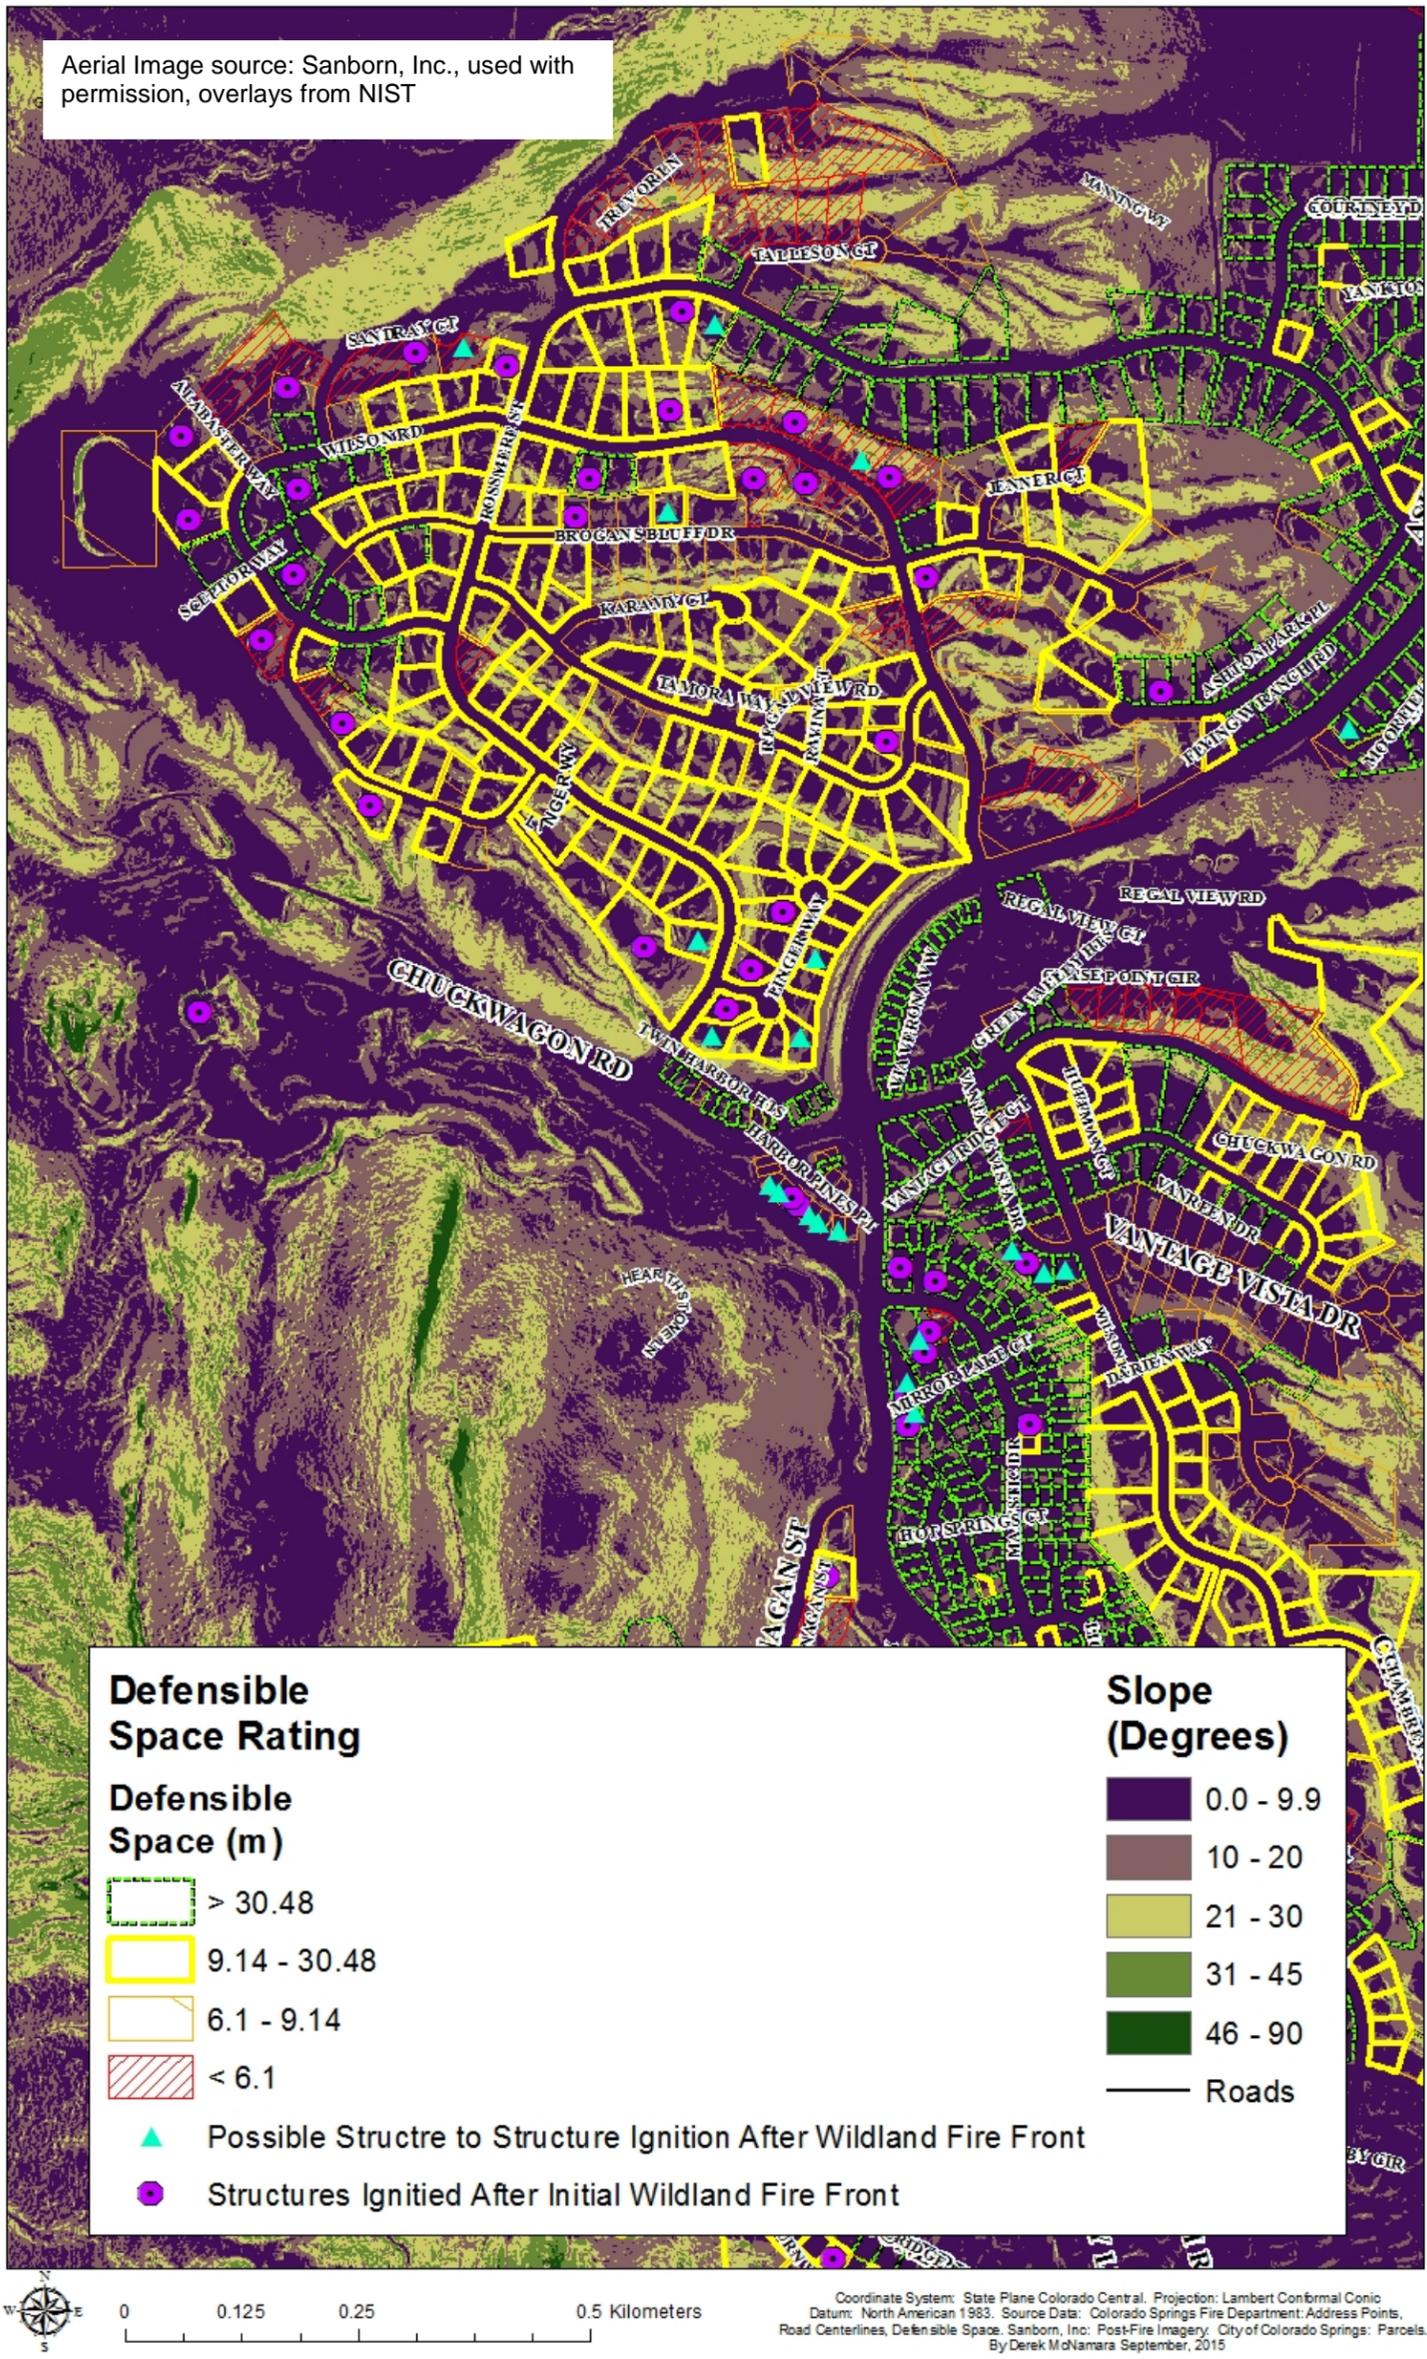
Map Figure 34 Defensible space ratings for select properties with primary structures in MSC overlaid with structure response to the Waldo Canyon Fire.

Examination of Map Figure 34, Figure 53 and Figure 54 demonstrates the failure of current concepts of defensible space at certain areas affected by the Waldo Canyon Fire and the failure of the HIZ concept. The figures and tables referenced above do show an expected relationship for primary structures with “No Damage”, in that, as the defensible space goes down, the number with “No Damage” also goes down. The relationship between hazard rating and damaged/destroyed primary structures is not anticipated, as the number of damaged/destroyed primary structures would be expected to increase as the defensible space was reduced. Viewed

This is demonstrated through a simple exercise where those properties with defensive actions are removed from the populations, shown in Map Figure 34, Figure 53 and Figure 54. The percent of primary structures with no damage are then plotted by defensible space rating, as shown in Figure 55. Next, the set of properties with defensive actions is examined and the percent of primary structures with no damage from the Waldo Canyon Fire are plotted by defensible space rating, as shown in Figure 56.

As can be seen in Figure 55 and Figure 56, the relationship between increased defensible space and primary structure response to the Waldo Canyon Fire when only considering those primary structures that were not defended or only those defended, is the opposite of what would be expected. Again, there is not a strong relationship, but even a flat relationship is not anticipated given current beliefs in the HIZ and defensible space concepts. Further analysis is required, but certain points are evident from examination of Map Figure 34 and Figure 53 through Figure 56.

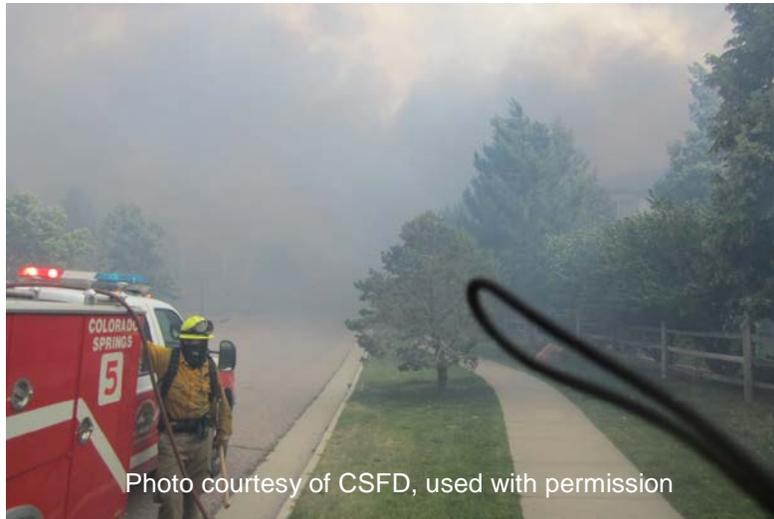
Camera clocks were checked for accurate time stamps using various methods described below. One method to check time stamps was the method used for TD144. Original images provided by the first responder were obtained during the first visit to Colorado Springs in July, 2012. The images provided by the first responder came from two cameras. At the time of acquiring the images, the dates and time were checked and it was found that both cameras had time as AM when it should have been PM, and that one camera had times stamps one hour early. This enabled accurate time stamping of the provided images, which were also checked against AVL time-stamped locations of first responders in certain images such as the image shown below.

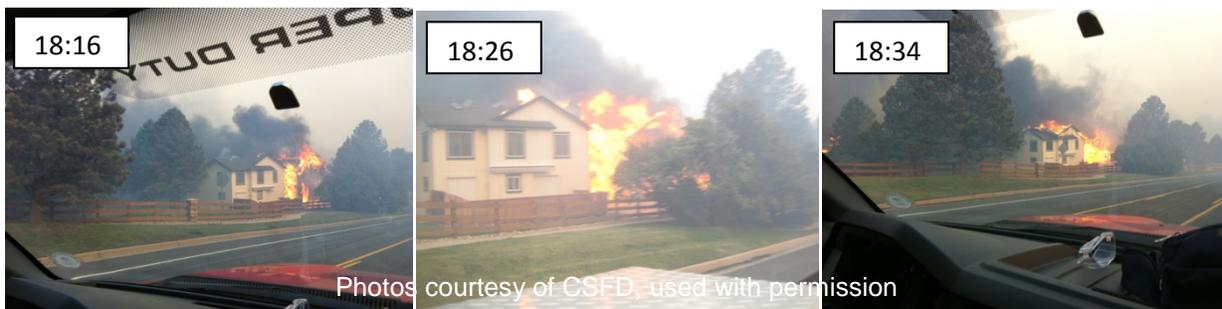
Ideally, if the camera had a reasonable time stamp it was examined against other data to ensure correctness. For example, the images below show three images from three separate first responders portraying burning of the same primary structure. The center image is from TD144 and has a confirmed time stamp. The images to the left and right all fall within reasonable bounds and the time stamp is assumed to be correct within ± 10 min for both the left and right images.

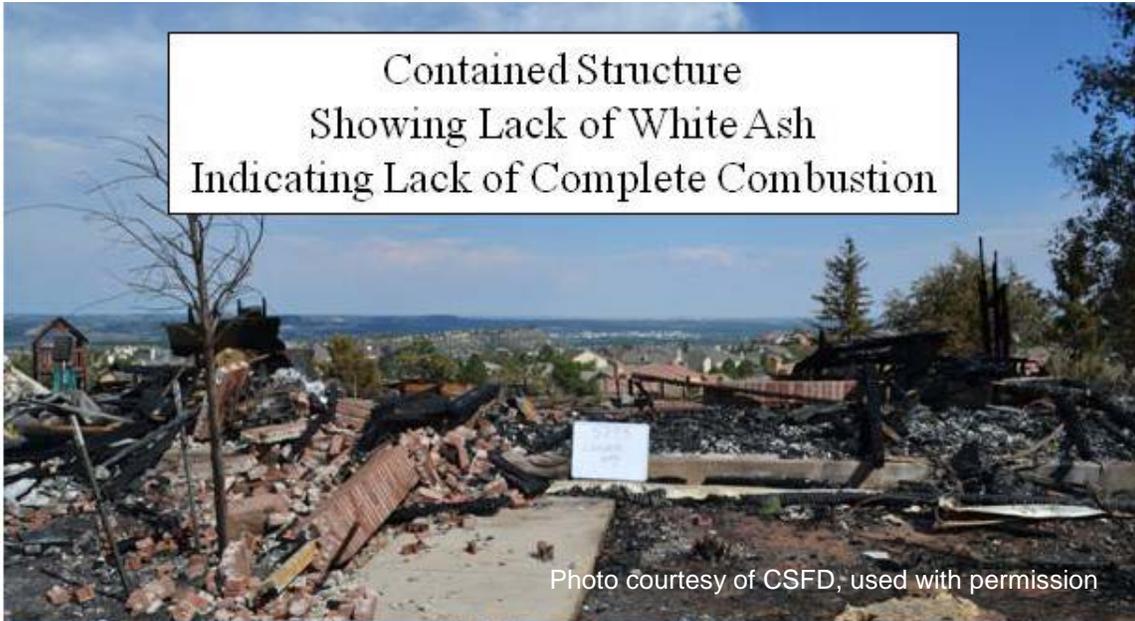
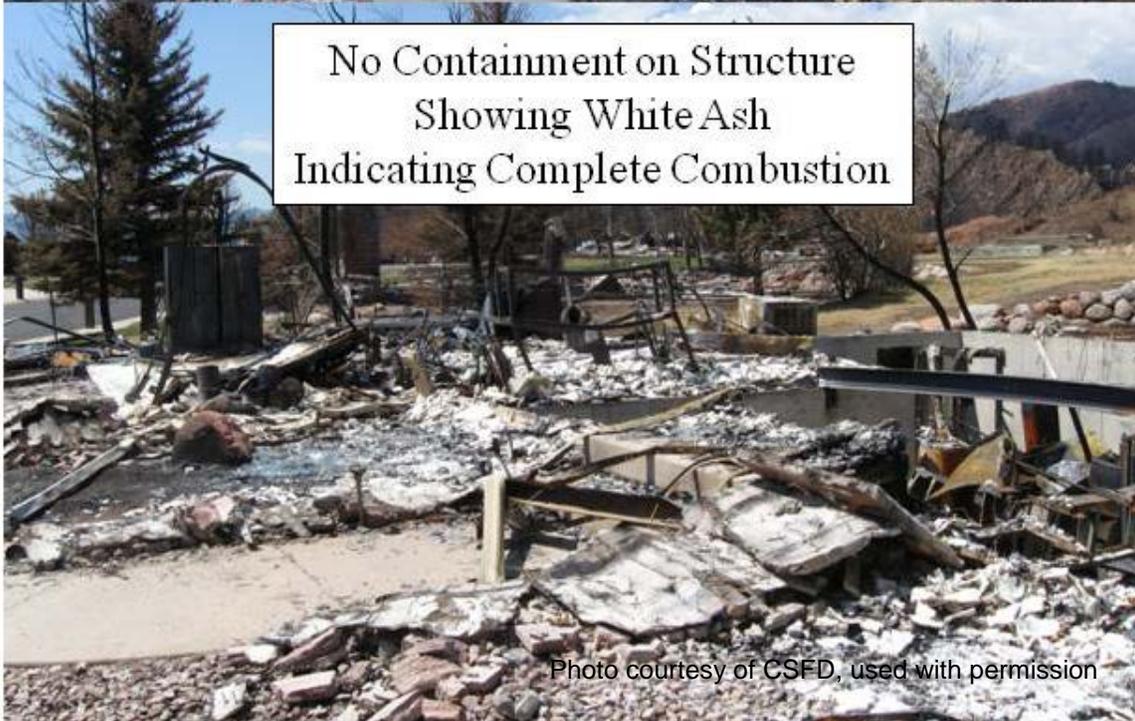
Example of destroyed primary structure contained with significant water resources and resultant lack of white ash or blackened appearance, along with destroyed primary structure with no containment action and white ash present.

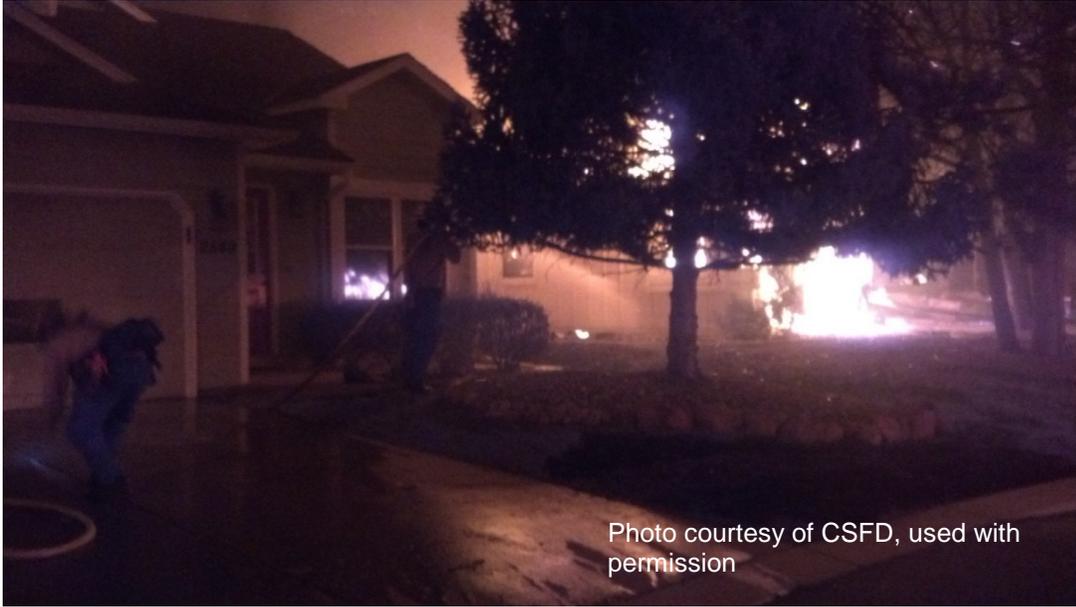
For example, the primary structure at 2549 HOT SPRINGS CT had two possible ignition mechanisms, which are not clearly identified by the simple list below. A firewood pile appeared to have ignited the composite lap siding causing a fire in the garage, which was extinguished by first responders, as shown in Appendix K Figure 1. The second ignition mechanism was direct flame contact and radiant heat from 2551 HOT SPRINGS CT, which was contained by first responders through application of water on 2551 HOT SPRINGS CT, as shown in Appendix K Figure 2, and application of water to the exposed side of 2549 HOT SPRINGS CT.

Appendix K Figure 2 Containment actions which resulted in successful containment of fire spread from 2551 HOT SPRINGS CT to 2549 HOT SPRINGS CT. Note multiple windows on exposed side of 2551 HOT SPRINGS CT, which could have helped spread fire if not contained by first responders.

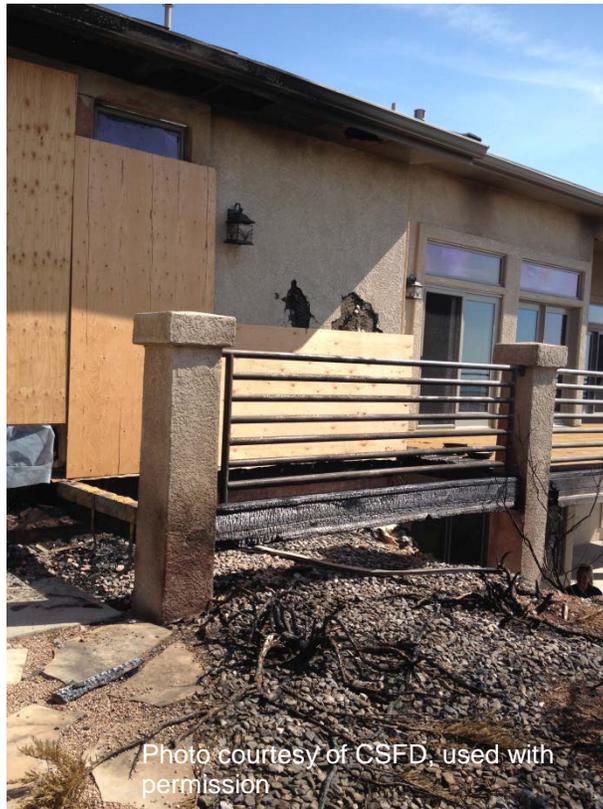
Another example is seen at 6260 WILSON RD, where TDs identified the damage as an attic ignition. The first NIST/USFS field visit, however, identified burned features as shown in Appendix K Figure 3. This identified other features than the attic as possible ignition mechanisms.

Appendix K Figure 3 Possible first items ignited at X could have been a Juniper bush, which ignited the deck or the deck ignited the primary structure and the bushes. In either case there was green vegetation between the burned items shown above and other burned vegetation or features.
